Limited Hazardous Building Materials Inspection

Lillis Administrative Building
50 East Street
New Milford, Connecticut

Town of New Milford
New Milford, CT

October 2, 2023

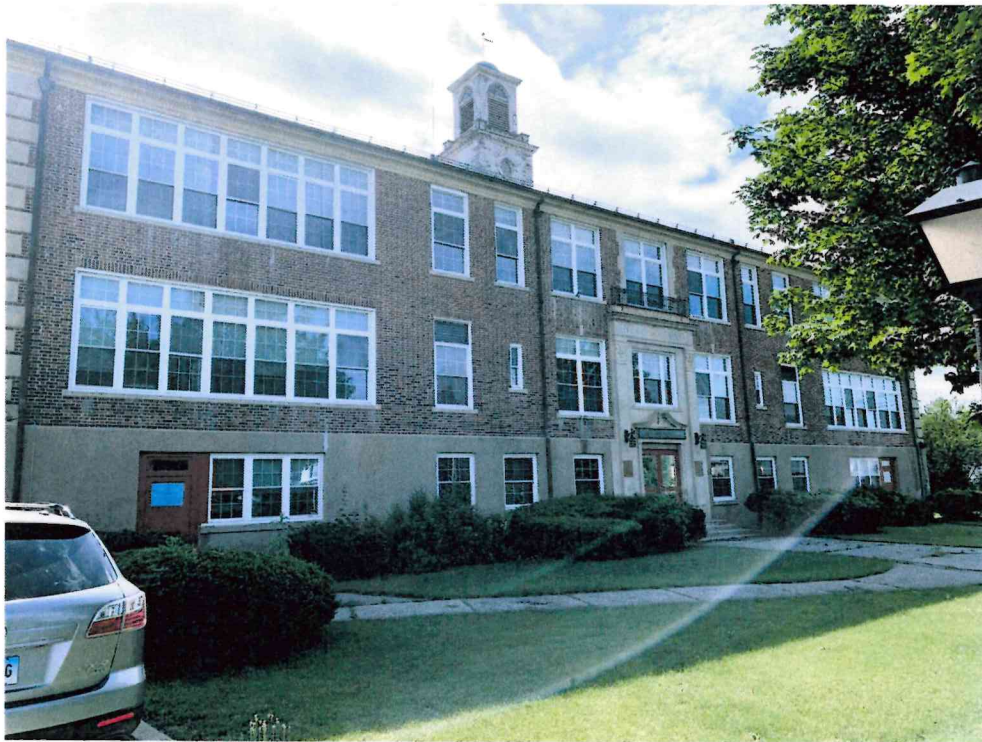
Photo1: Site building front entrance (western elevation) – Residual exterior window caulking compound identified as ACM possibly located at all windows including new vinyl replacement windows.

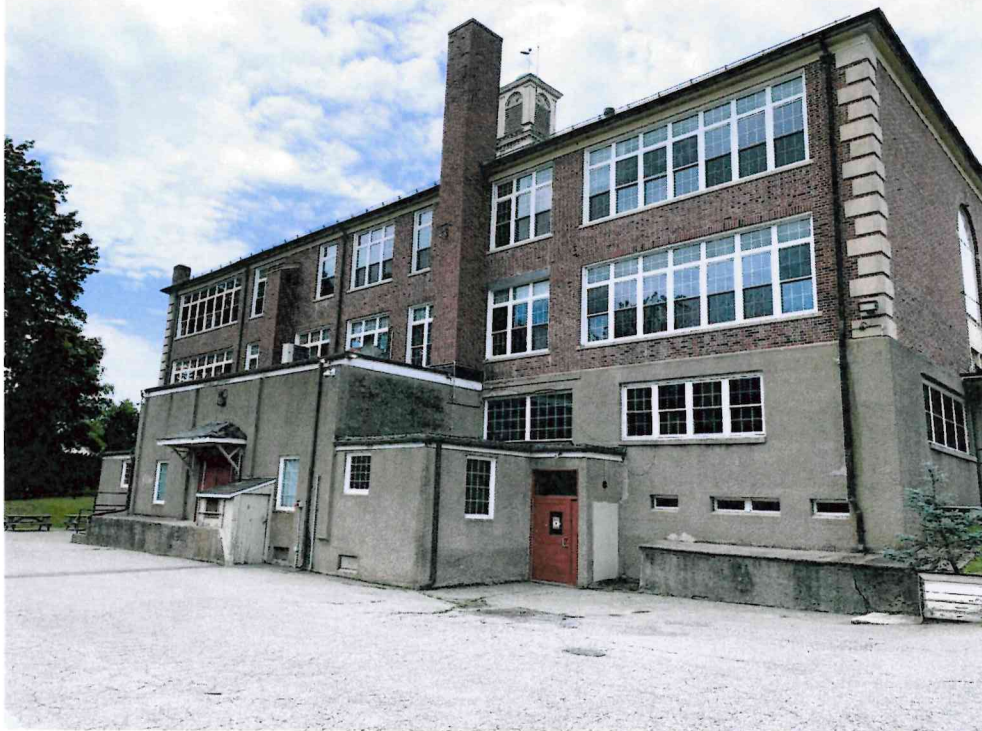
Photo 2: Site building rear entrances (eastern elevation) – Residual exterior window caulking compound identified as ACM possibly located at all windows including new vinyl replacement windows.

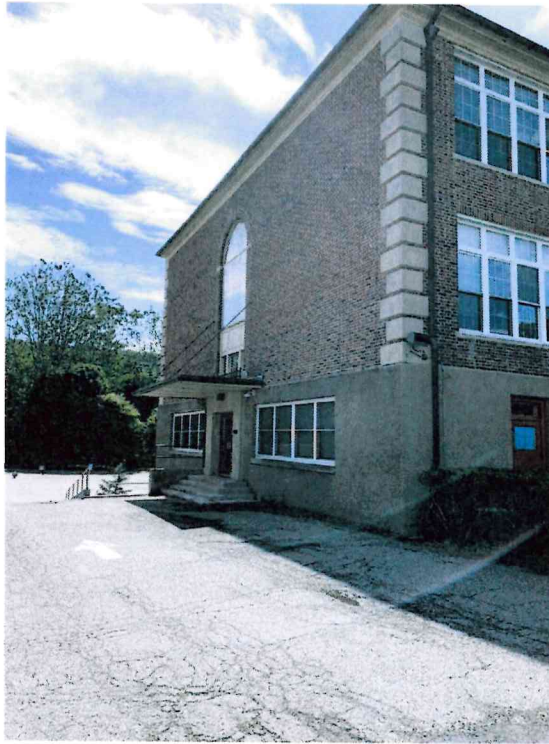
Photo 3: Site building northern elevation — Residual exterior window caulking compound identified as ACM possibly located at all windows including new vinyl replacement windows.

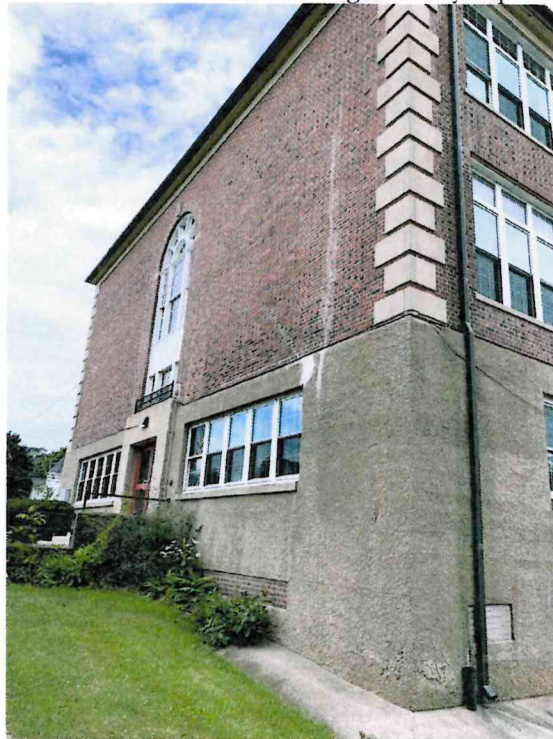
Photo 4: Site building southern elevation — Residual exterior window caulking compound identified as ACM possibly located at all windows including new vinyl replacement windows.

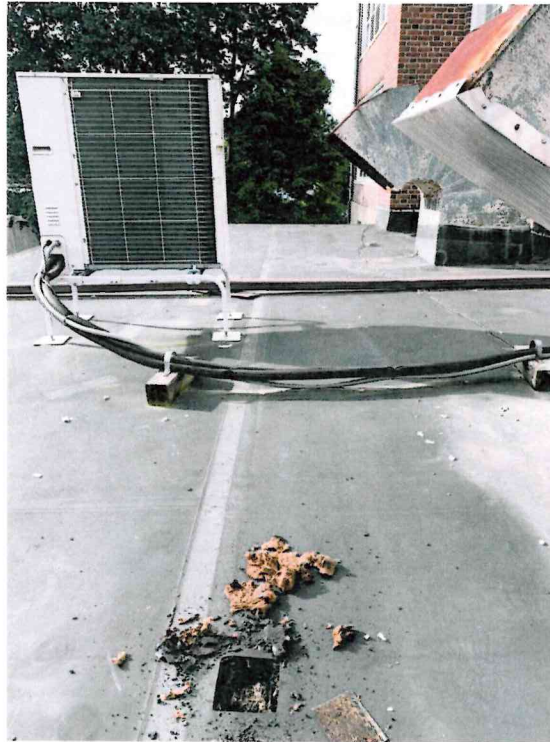
Photo 5: Upper (central) flat roof. Asbestos containing black tar and roof felt.

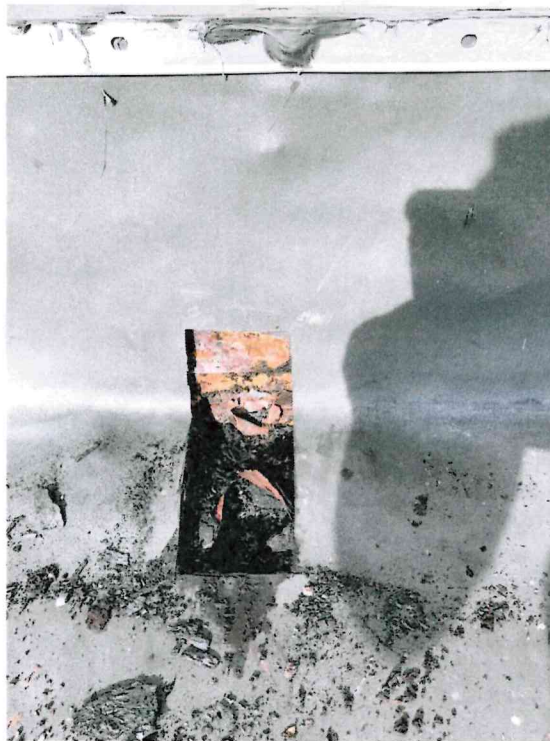
Photo 6: Upper flat roof flashing – Black tar/roof cement wall flashing over copper flashing identified as ACM.

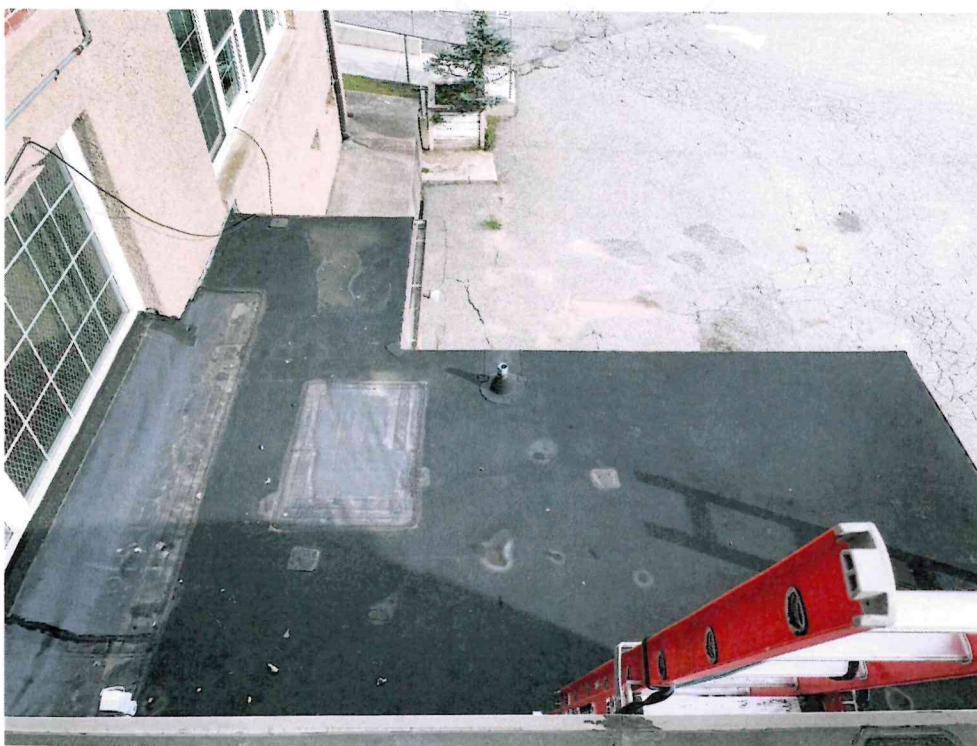
Photo 8: Lower flat roof (north end). Roof cement over flashing (repair shown below original windowsill) identified as ACM.

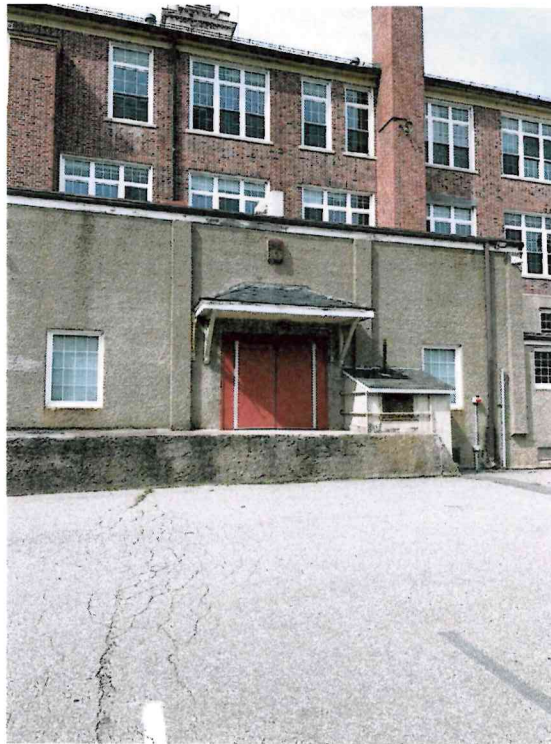
Photo 9: Lower slate (hip) roof and lower shed roof with black/gray caulking compound identified as ACM.

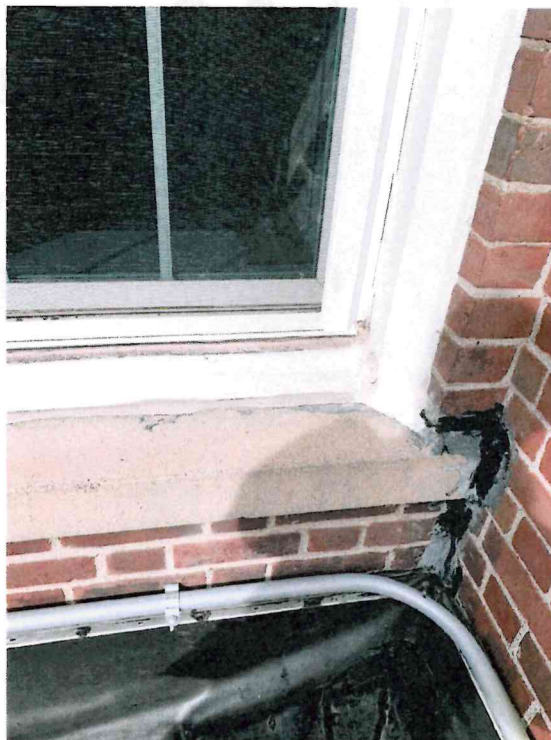
Photo 10: Black/gray caulking compound identified as ACM on brick wall at upper flat roof.

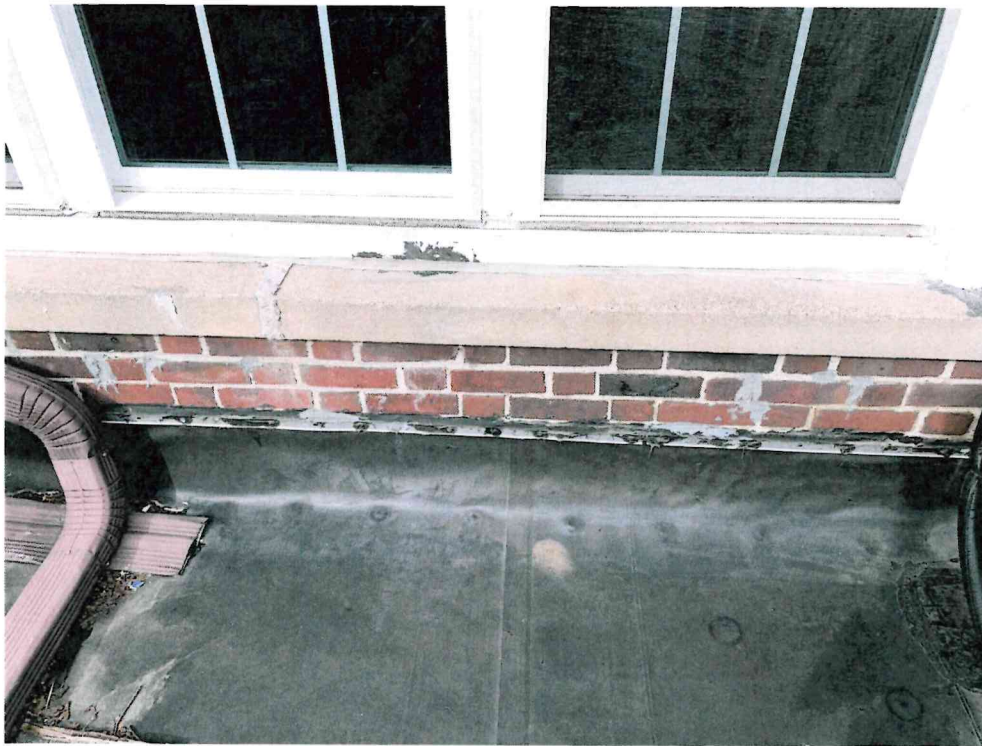
Photo 11: Black/gray caulking compound identified as ACM on brick wall at upper flat roof.

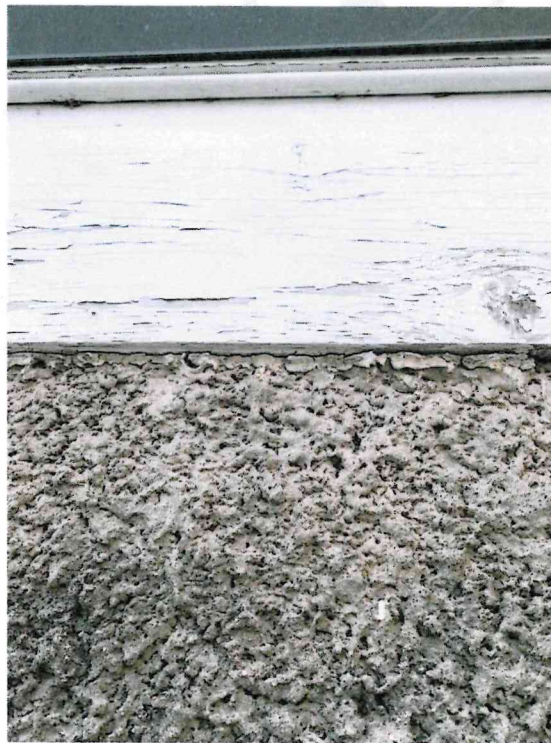
Photo 12: White caulking compound identified as ACM along upper flat roof fascia board.

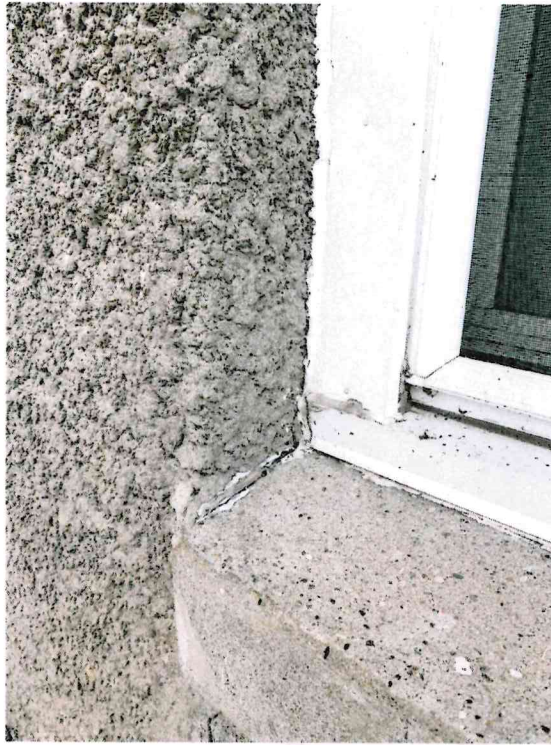
Photo 13: Typical residual asbestos containing caulking compound observed at new vinyl replacement windows (sampled at sill)

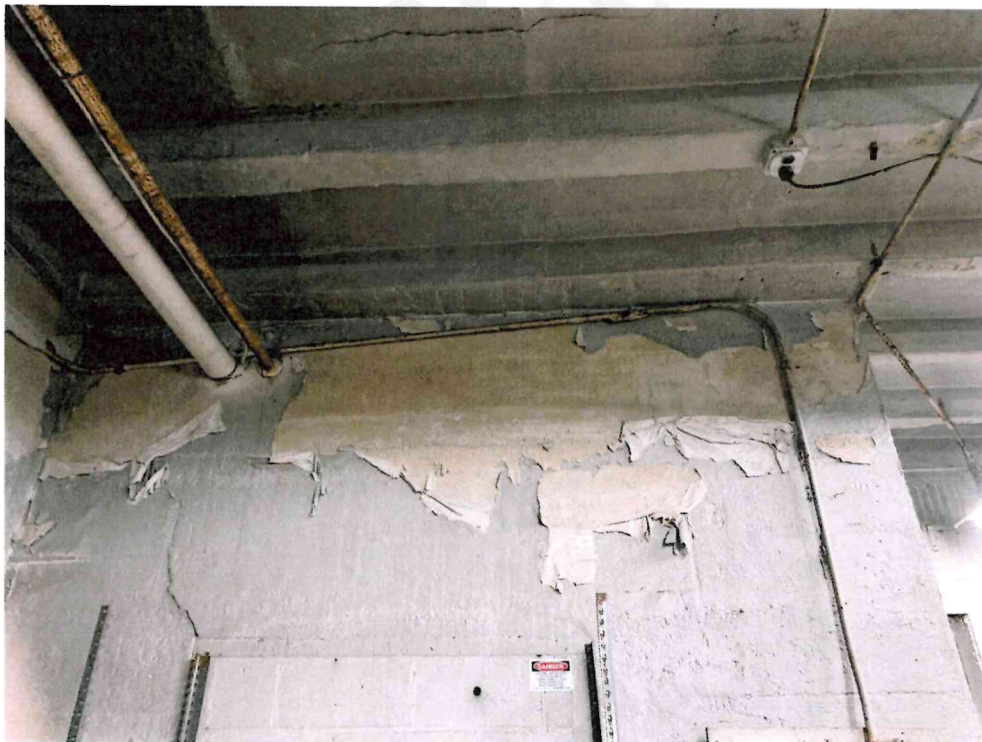
Photo 14: Basement Boiler Room – Silver paint identified as ACM shown.

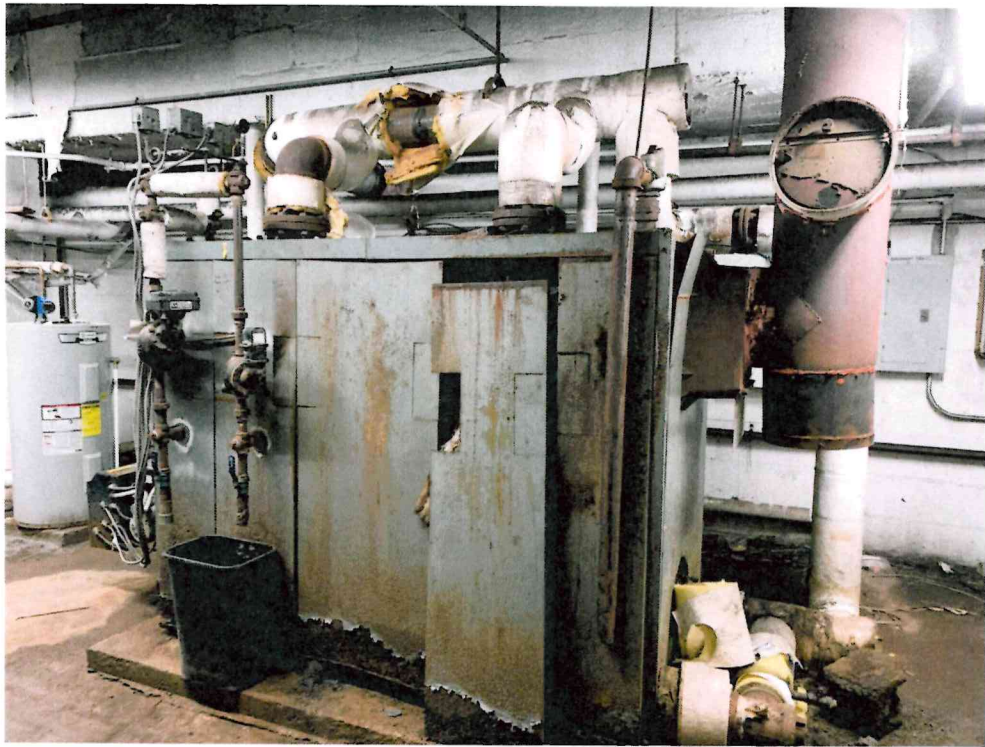
Photo 15: Basement Boiler Room – Boiler with assumed internal ACM components shown.

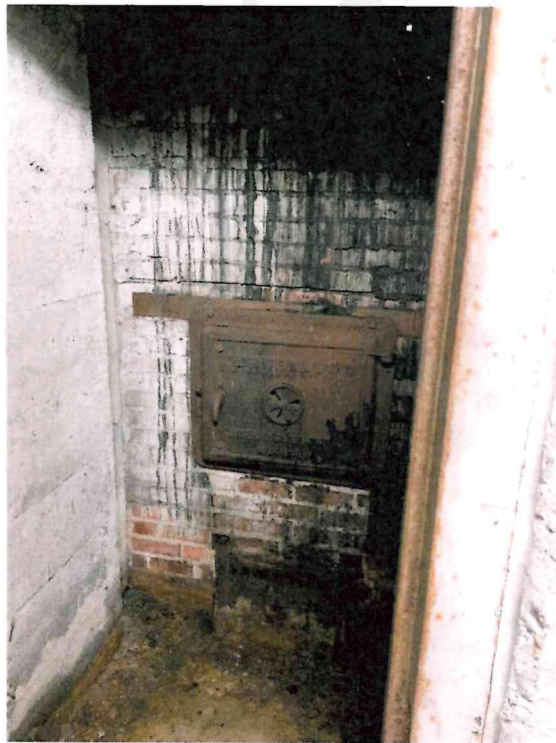
Photo 16: Basement Boiler Room – Incinerator with assumed internal ACM components shown.

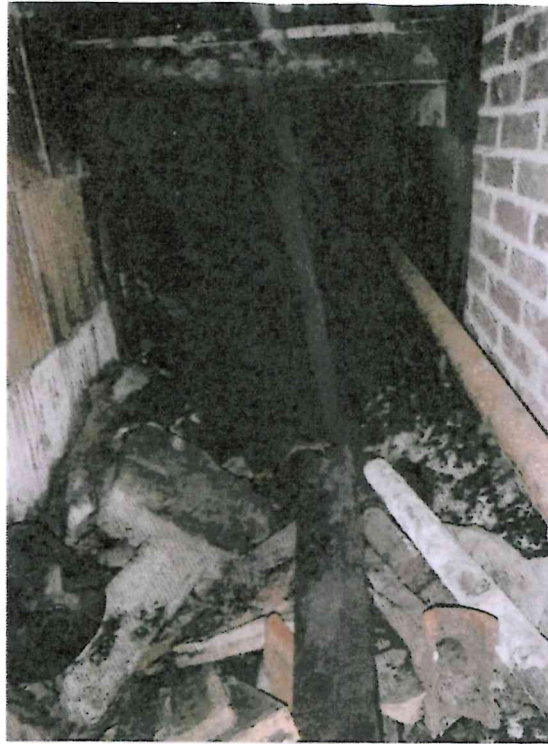
Photo 17: Basement northern tunnel system. Debris with potential buried ACM shown.

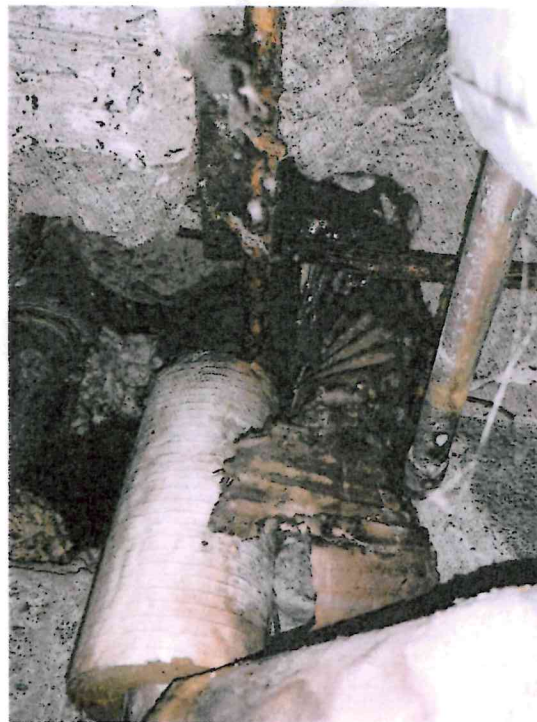
Photo 18: Basement northern tunnel system – Location of air cell pipe insulation (not visible in photo) and suspect corrugated cardboard at northeastern ceiling shown.

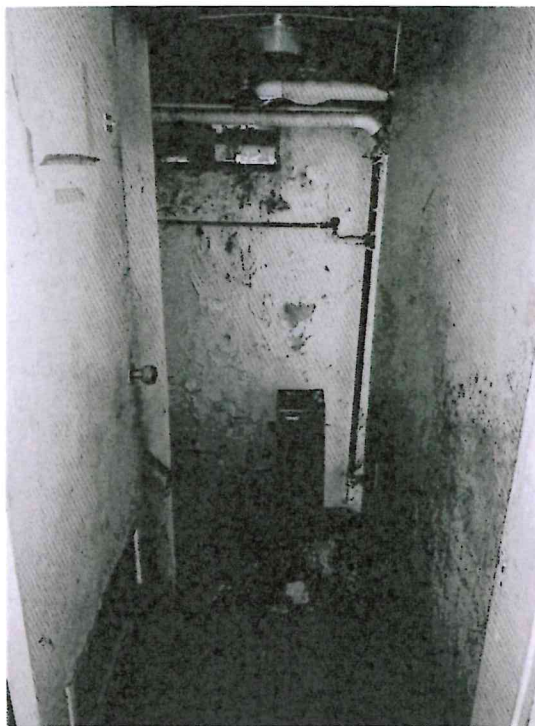
Photo 19: Basement – Northern men’s bathroom. Light fixture with asbestos containing paper, original metal window with asbestos containing caulking and glazing compounds, and 9”x9” red/brown asbestos containing floor tiles shown.

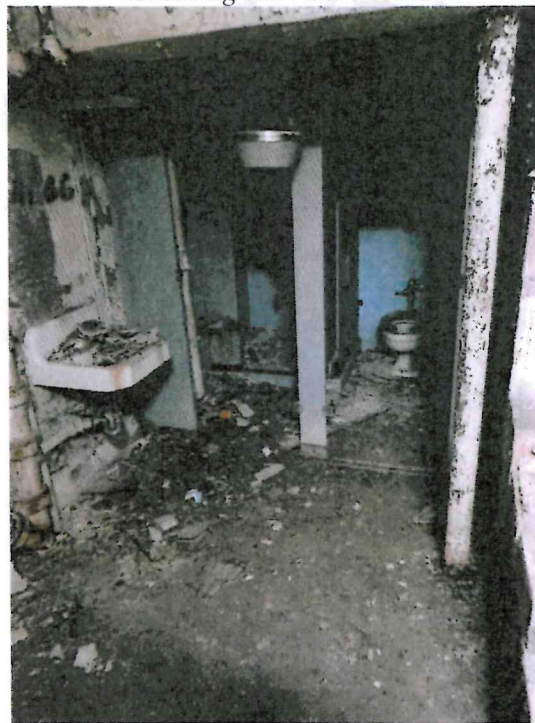
Photo 20: Basement – Southern (women’s) bathroom. Light fixture with asbestos containing paper, and 9”x9” red/brown asbestos containing floor tiles shown.

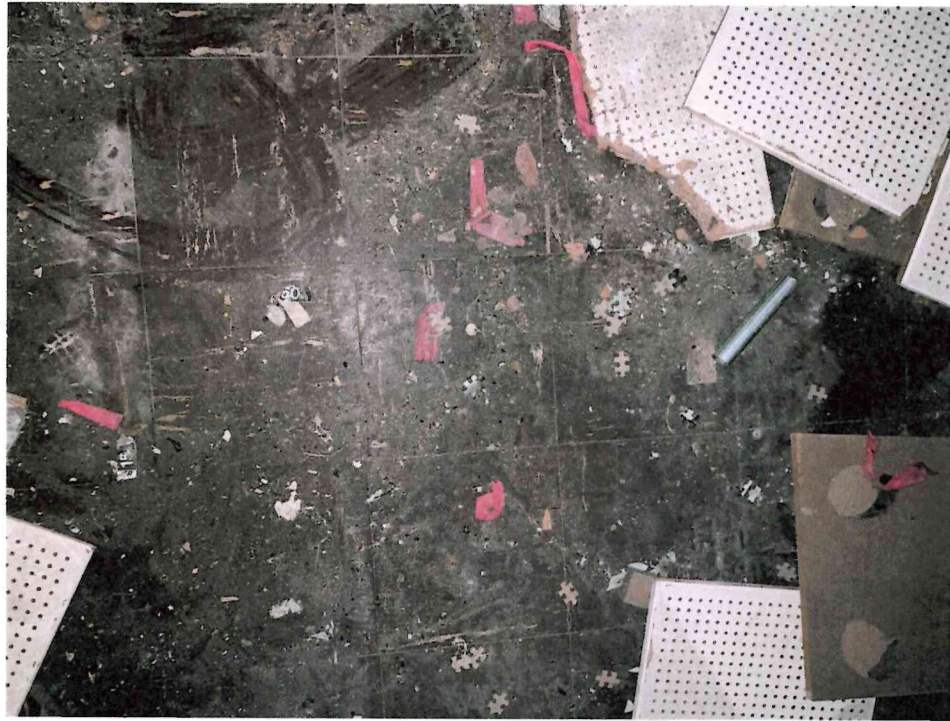
Photo 21: Basement – Northern (men's) bathroom. 9"x9" red/brown asbestos containing floor tiles shown.

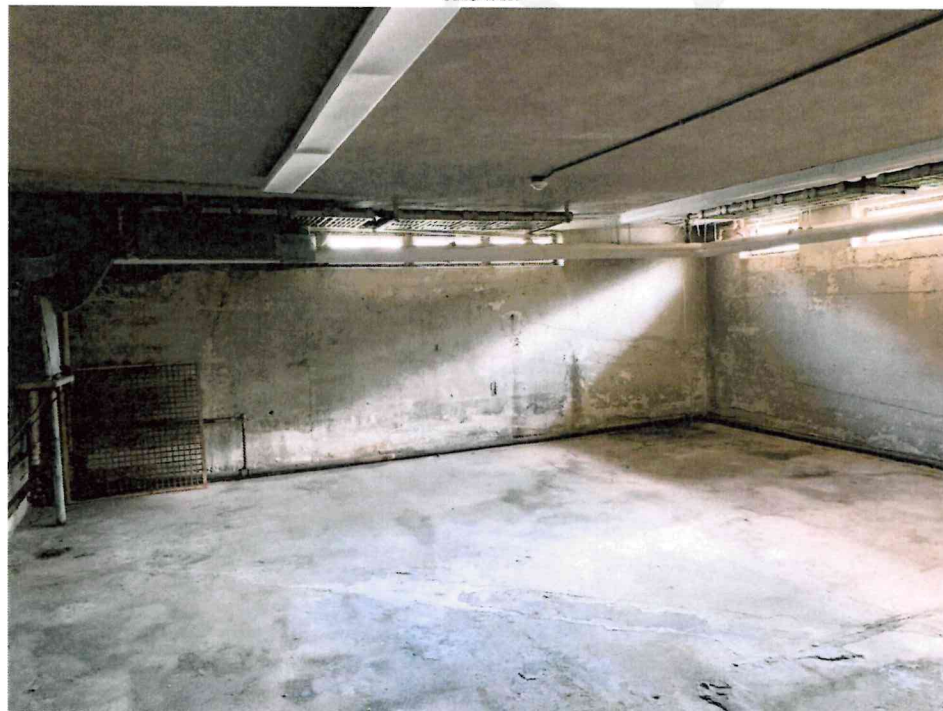
Photo 22: Lower-level mechanical room (northeast) - Ventilation system with white cloth vibration dampeners, silver paint on walls and ceiling (assumed ACM) shown and new vinyl replacement windows with possible residual ACM caulk shown.

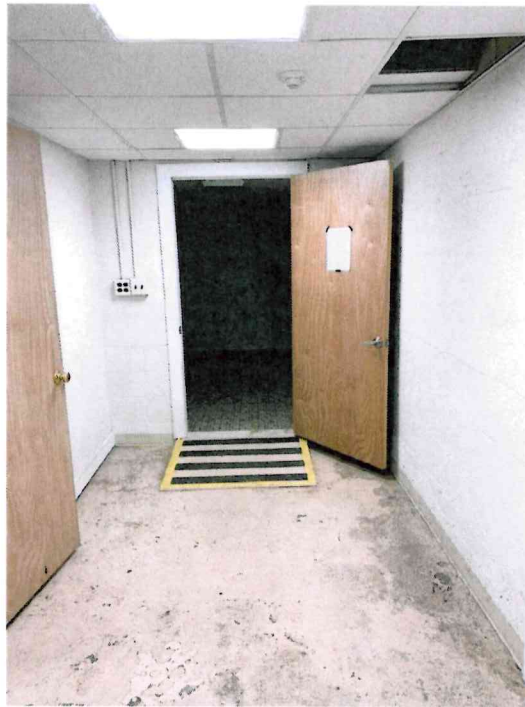
Photo 23: Lower level northwest storage entry/vestibule - Gypsum/joint compound wall system (at right) with joint compound identified as <1% asbestos containing and cove base molding with possible residual asbestos containing black adhesive shown.

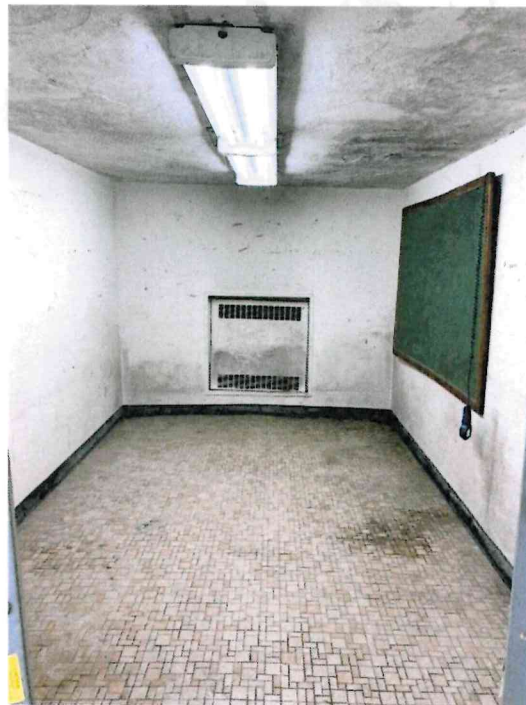
Photo 24: Lower level northwest storage storage/former shower (northwest). Gypsum/joint compound wall system with joint compound identified as <1% asbestos containing and cove base molding with possible residual asbestos containing black adhesive shown.

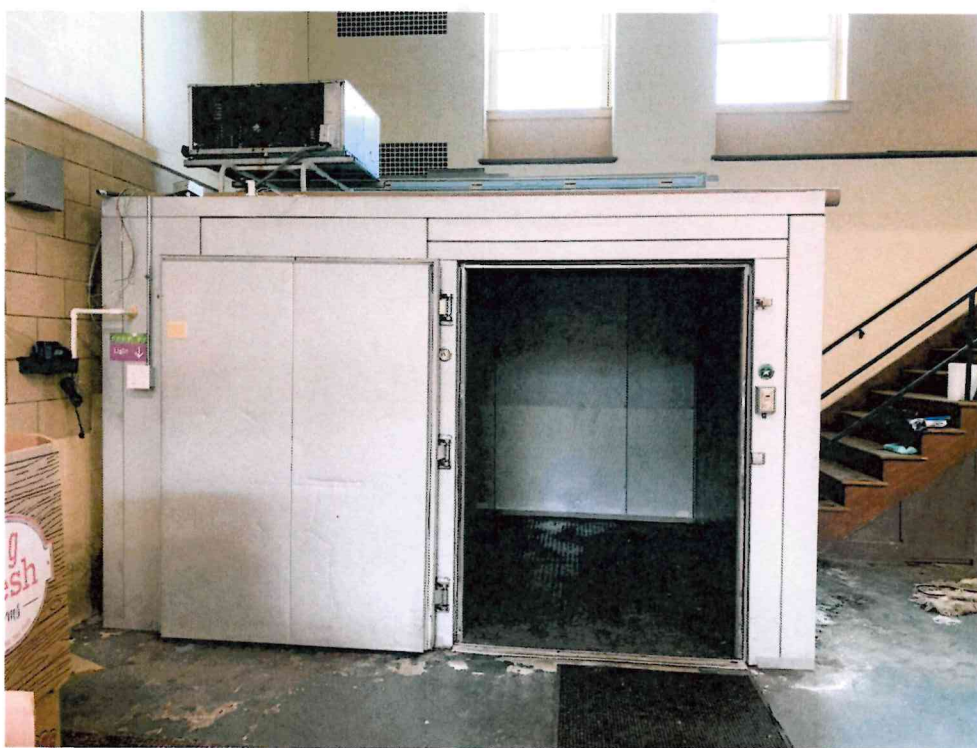
Photo 26: Walk-in freezer located in the Gym. Interior caulk and insulation assumed ACM.

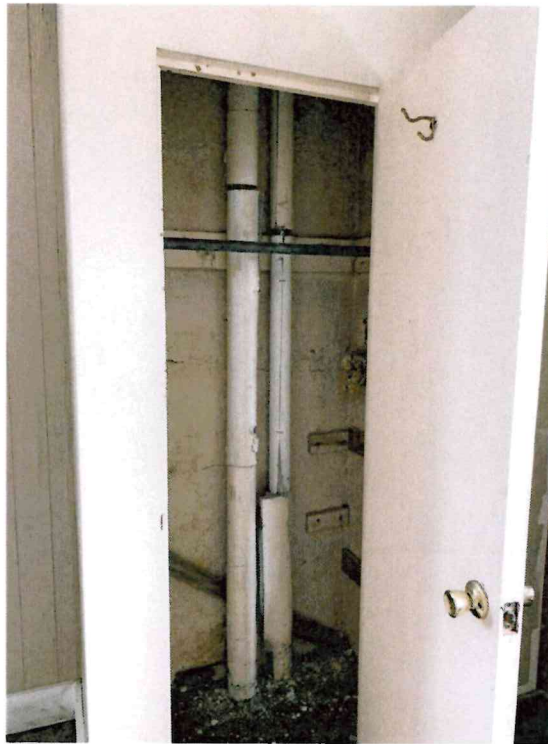
Photo 27: 1st Floor Room 3 – ACM air cell pipe insulation and associated debris in closet shown.

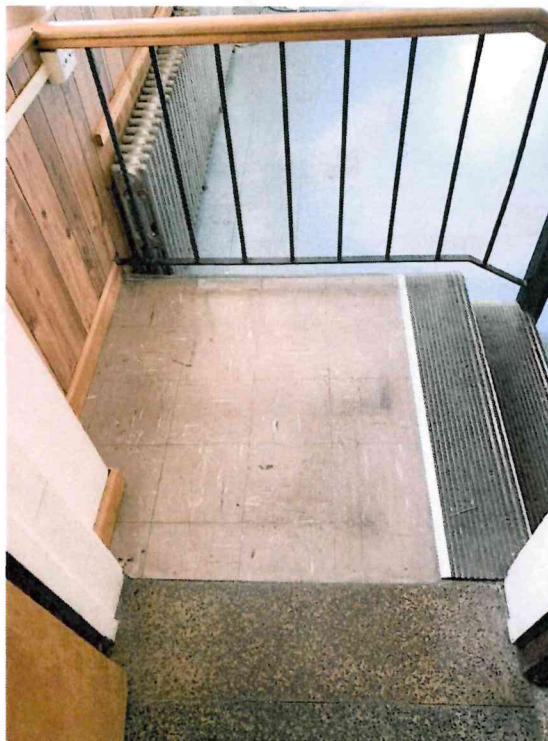
Photo 28: 1st Floor Room 1 (northeast) – Typical brown/tan 9"x9" vinyl floor tiles identified as ACM shown. Asbestos containing floor tiles and mastic located beneath blue 12"x12" flooring.

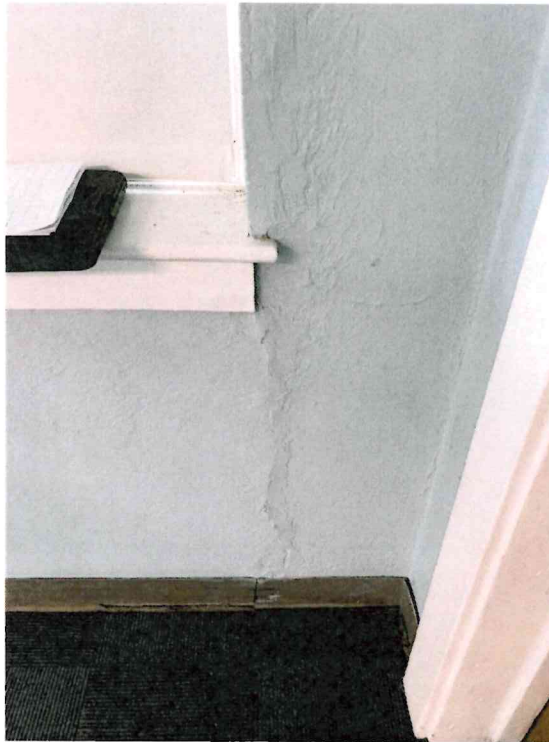
Photo 29: 1st Floor Room 2 (northwest) – Typical 4” brown cove base molding with possible residual asbestos-containing black adhesive.

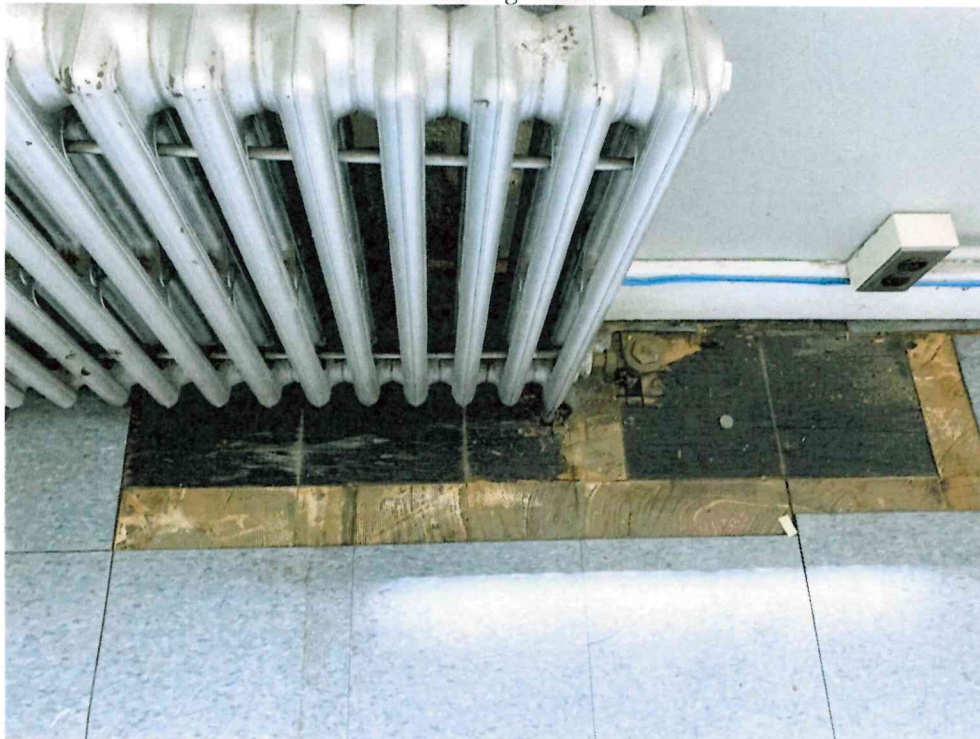
Photo 30: 1st Floor Room 3 (southeast) – Typical layered flooring shown. Non-ACM floor tile located over 9”x9” flooring and black mastic identified as ACM.

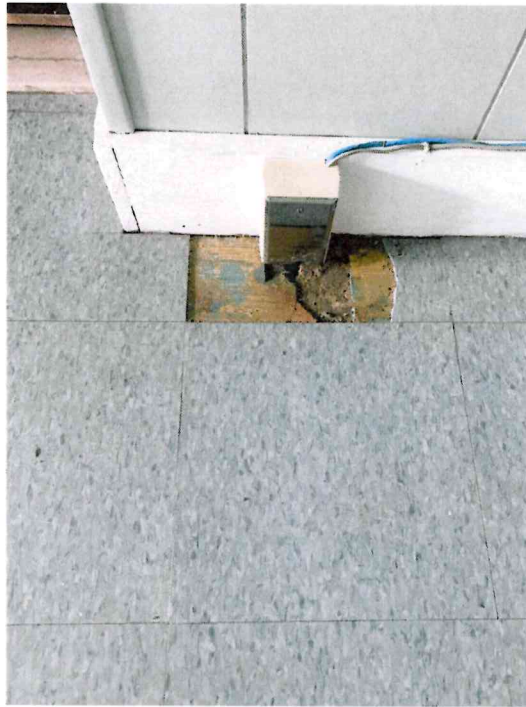
Photo 31: 1st Floor Room 3 (southeast) – Blue tile below light blue 12x12 mottled vinyl floor tile identified as ACM (located on brown/tan 9x9 and associated mastic also identified as ACM).

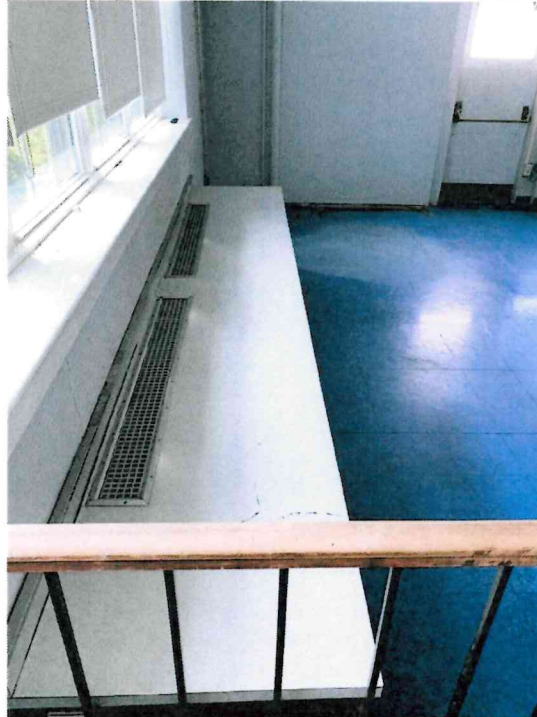
Photo 32: 1st Floor Room 4 (southwest) – Cement board (assumed ACM) observed at back of cabinet.

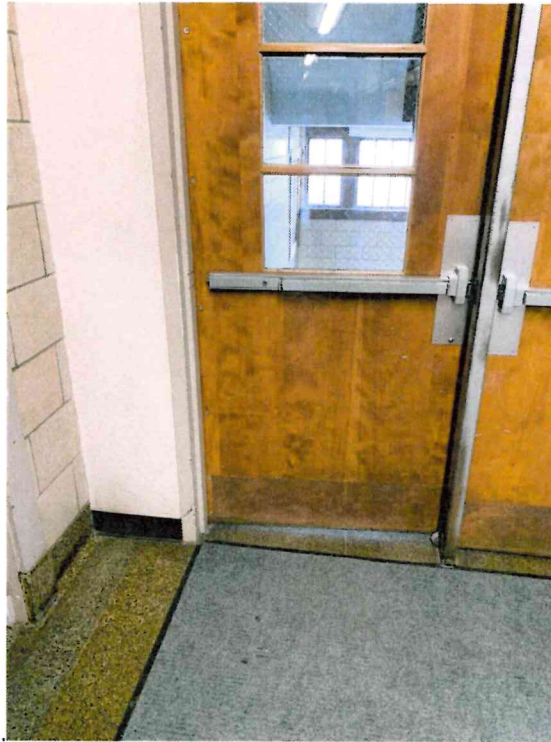
Photo 33: 2nd Floor Hallway – 4” cove base molding with possible residual asbestos containing black adhesive shown.

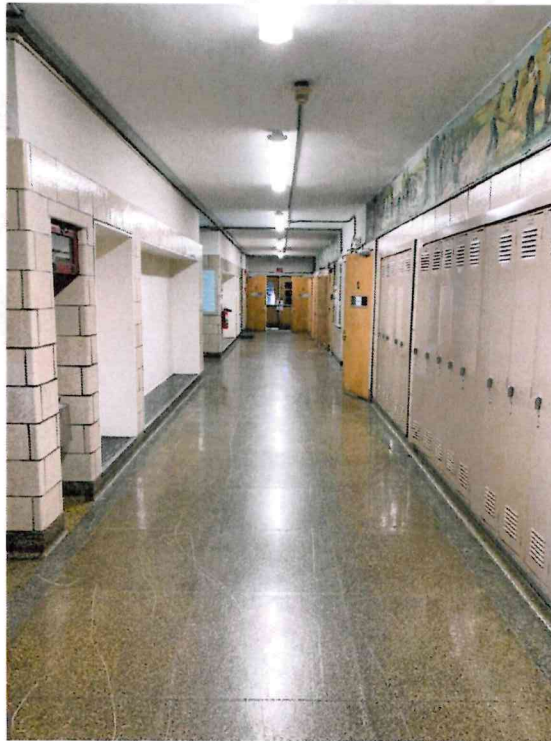
Photo 34: 2nd Floor Hallway – 9”x9” Black vinyl floor tile at former locker nooks identified as ACM. Associated black mastic none detected for asbestos content.

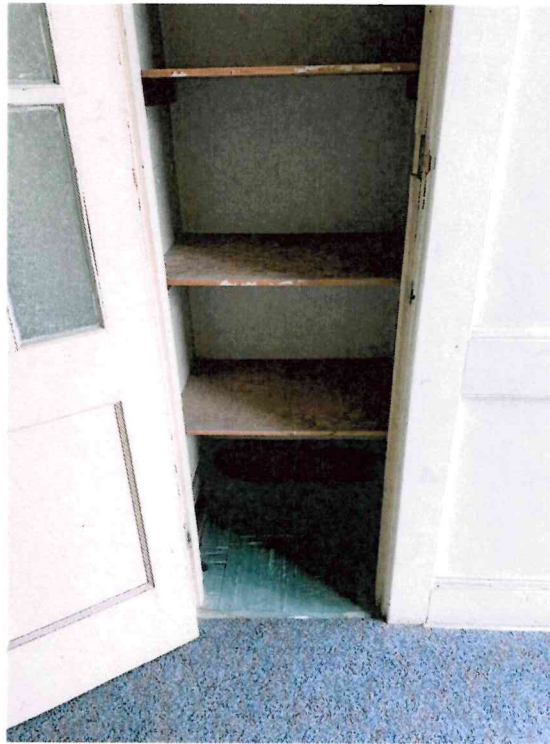
Photo 35: 2nd Floor Copy Room – Asbestos containing 9"x9" green floor tile and associated black mastic located in closet and below carpet.

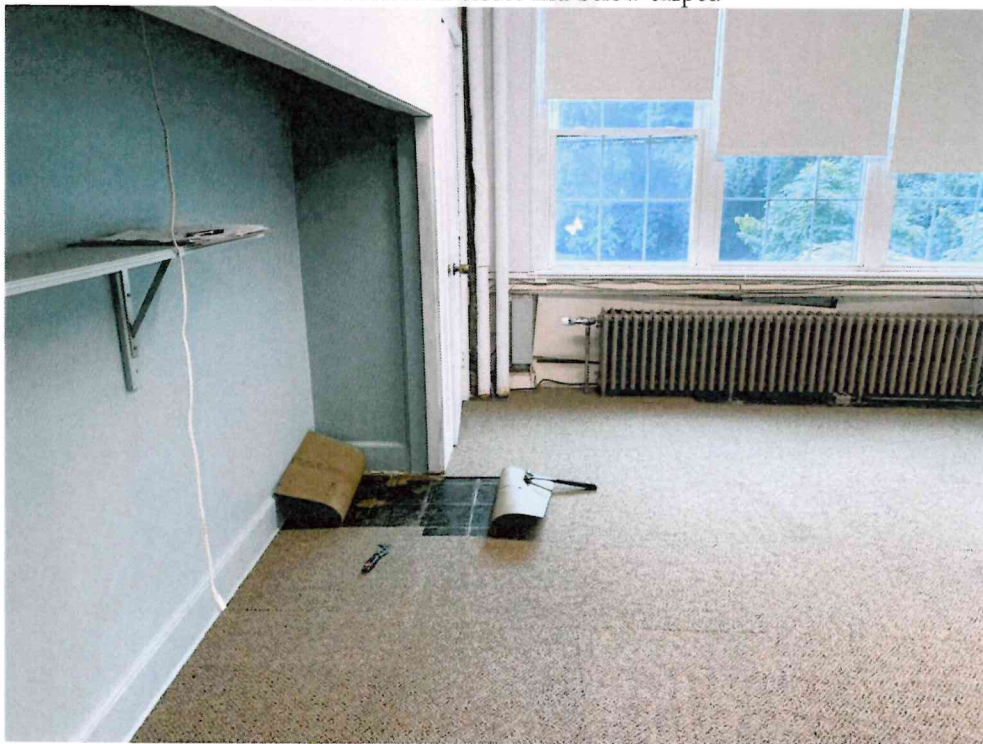
Photo 36: 2nd Floor Room 5 – Residual black mastic located below carpet on hardwood identified as <1% asbestos containing.

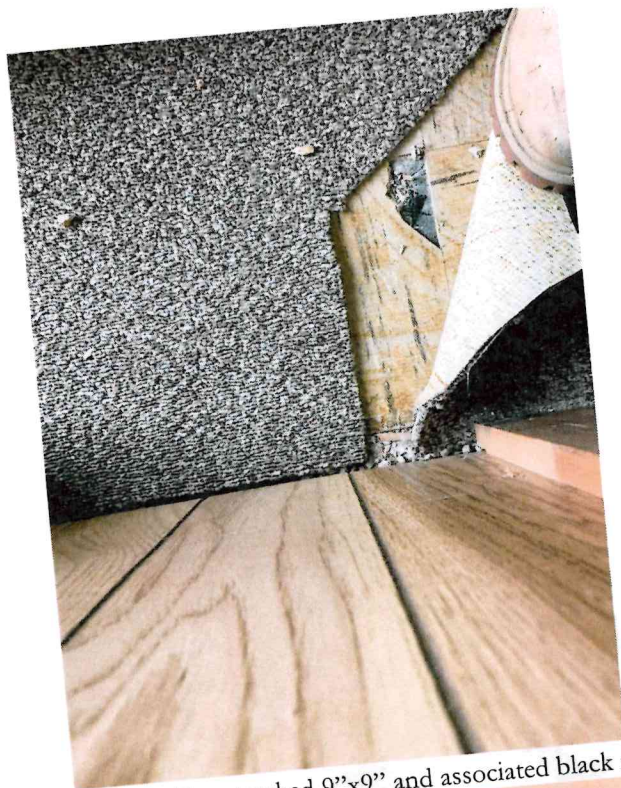
Photo 37: 2nd Floor Files Room – Tan streaked 9"x9" and associated black mastic identified as ACM.

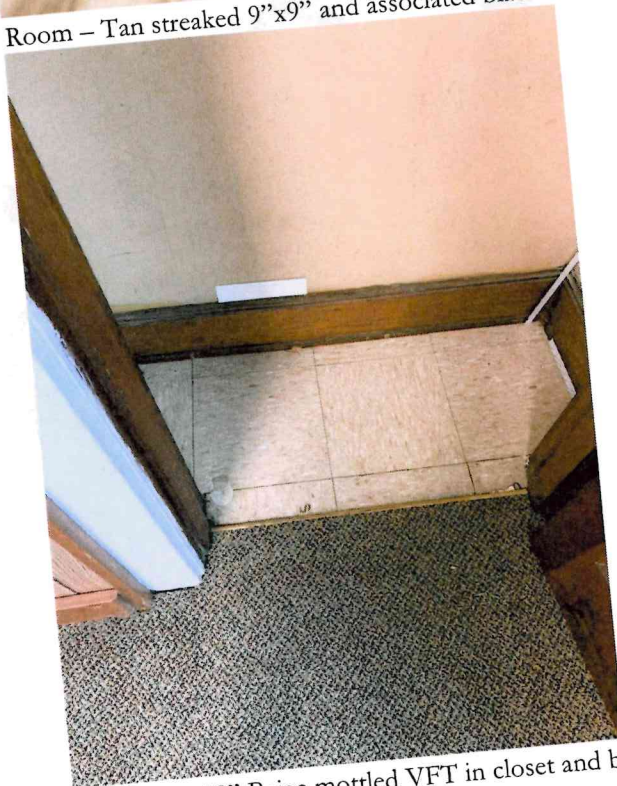
Photo 38: 2nd Floor Room 9 – 12"x12" Beige mottled VFT in closet and below carpet identified as ACM. Associated yellow mastic identified as <1% asbestos containing.

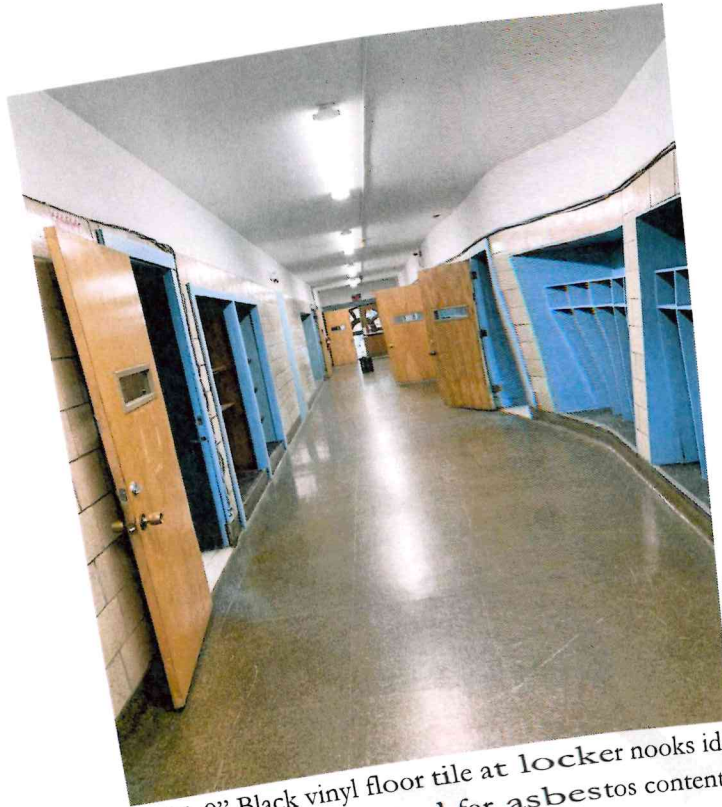
Photo 39: 3rd Floor Hallway – 9"x9" Black vinyl floor tile at locker nooks identified as ACM. Associated black mastic none detected for asbestos content.

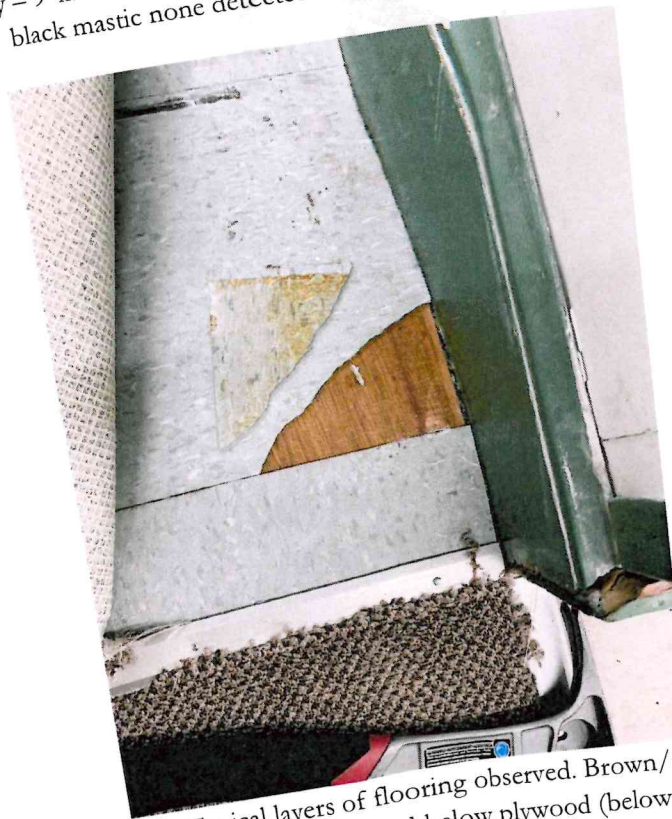
Photo 40: 3rd Floor Room 18 – Typical layers of flooring observed. Brown/tan 9"x9" vinyl floor tile and associated black mastic identified as ACM located below plywood (below blue floor tile and carpet).

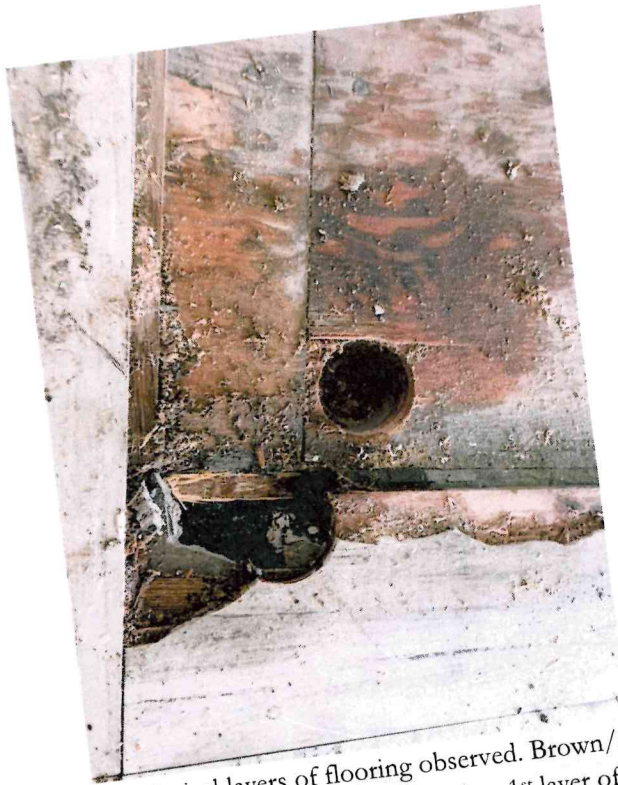
Photo 41: 3rd Floor Room 17 – Typical layers of flooring observed. Brown/tan 9"x9" vinyl floor tile and black mastic identified as ACM located below 1st layer of plywood.

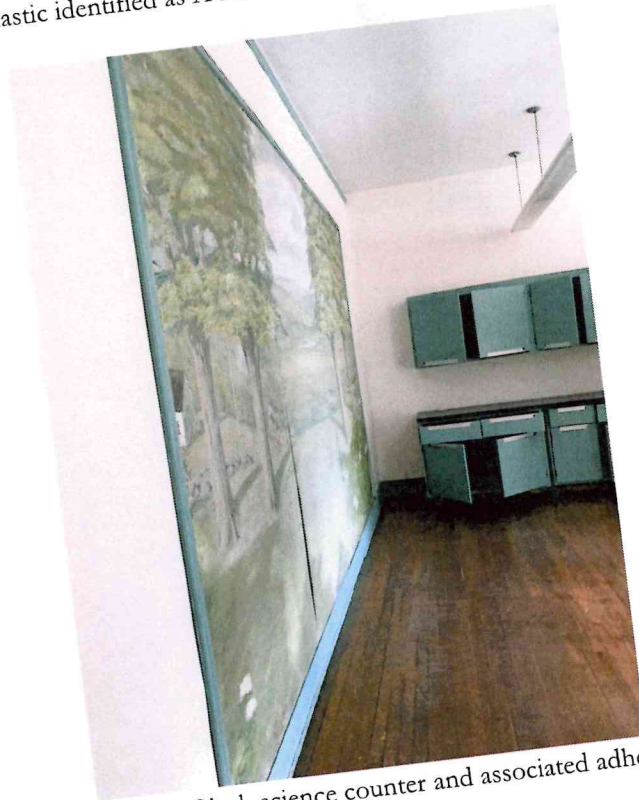
Photo 42: 3rd Floor Room 16 – Black science counter and associated adhesive identified as ACM.

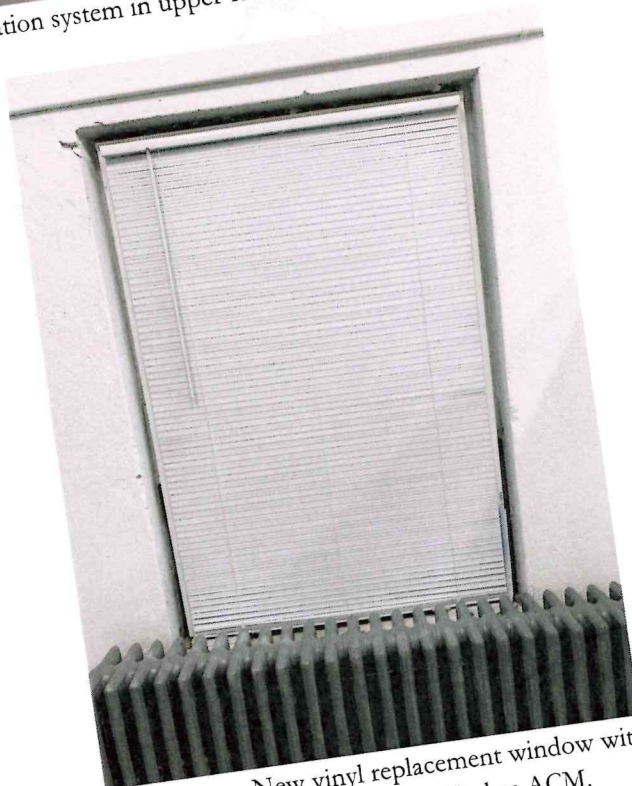
Photo 44: Lower-Level Food Pantry – New vinyl replacement window with residual original window caulking compound identified as ACM.

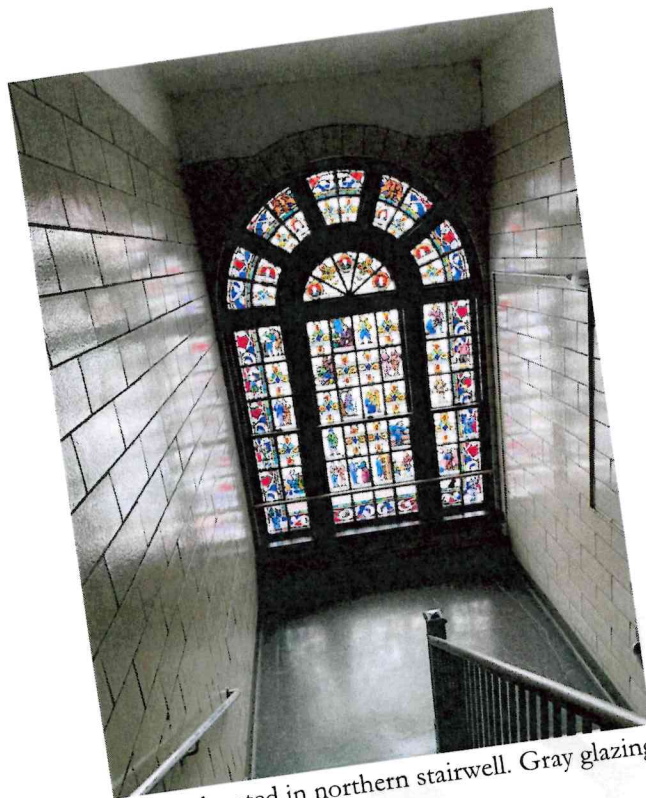
Photo 45: Stained glass window located in northern stairwell. Gray glazing compound identified as ACM.
