Limited Hazardous Building Materials Inspection

Lillis Administrative Building
50 East Street
New Milford, Connecticut

Town of New Milford
New Milford, CT

October 2, 2023

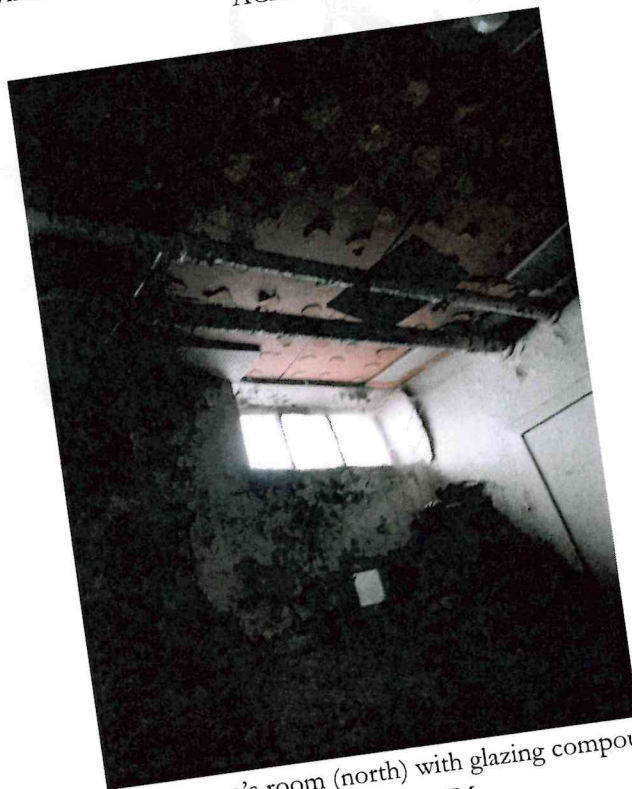
Photo 46: Basement window at men's room (north) with glazing compound and exterior caulking identified as ACM.

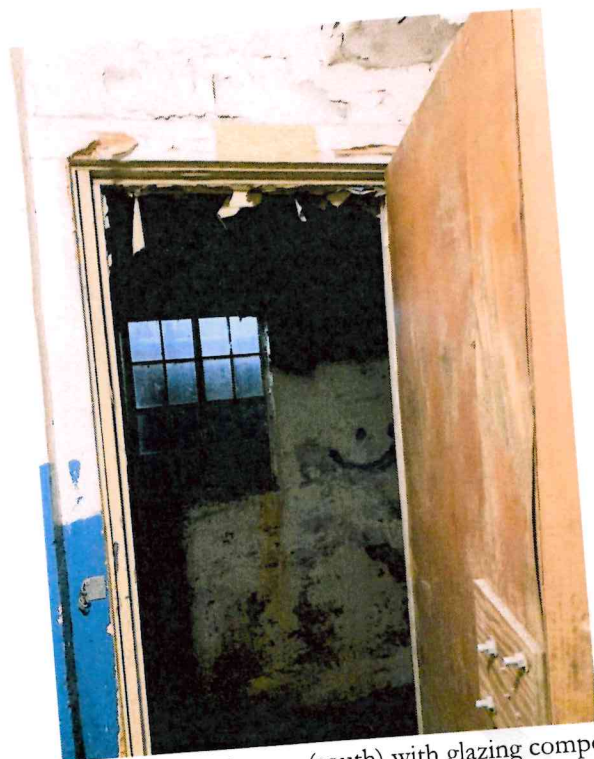
Photo 47: Basement window at women's' room (south) with glazing compound and exterior caulking identified as ACM.

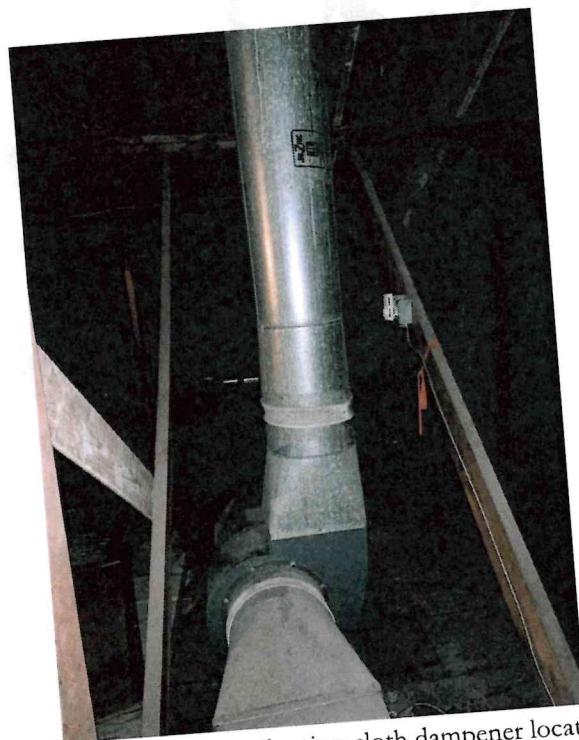
Photo 48: Asbestos containing vibration cloth dampener located in the Attic.

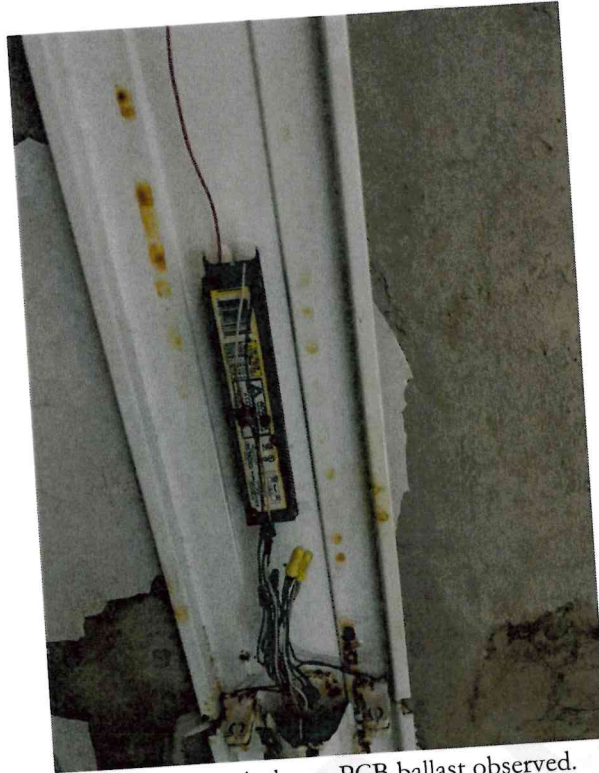
Photo 49: Typical non-PCB ballast observed.

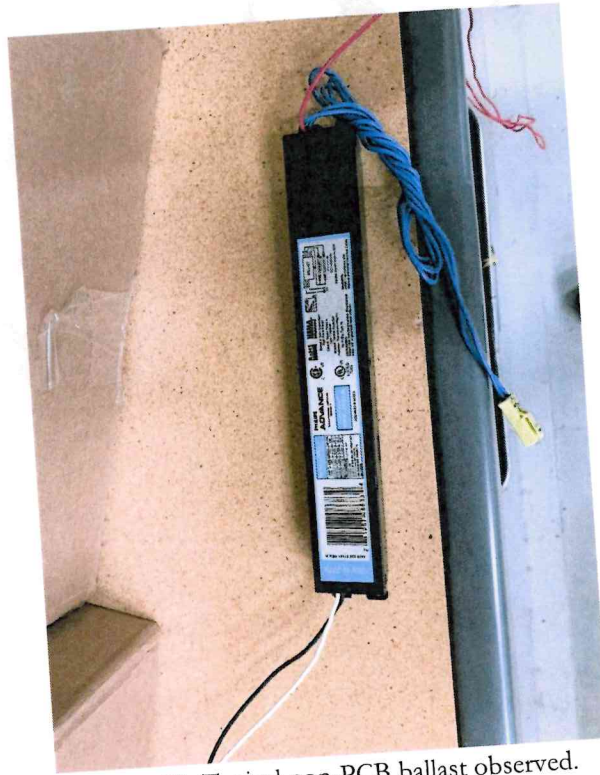
Photo 50: Typical non-PCB ballast observed.
