# NEW MILFORD ROAD SAFETY AUDIT

US Route 7 / US Route 202 (Danbury Road): Veteran's Memorial Bridge to Brookfield Town Line

OCTOBER 2024

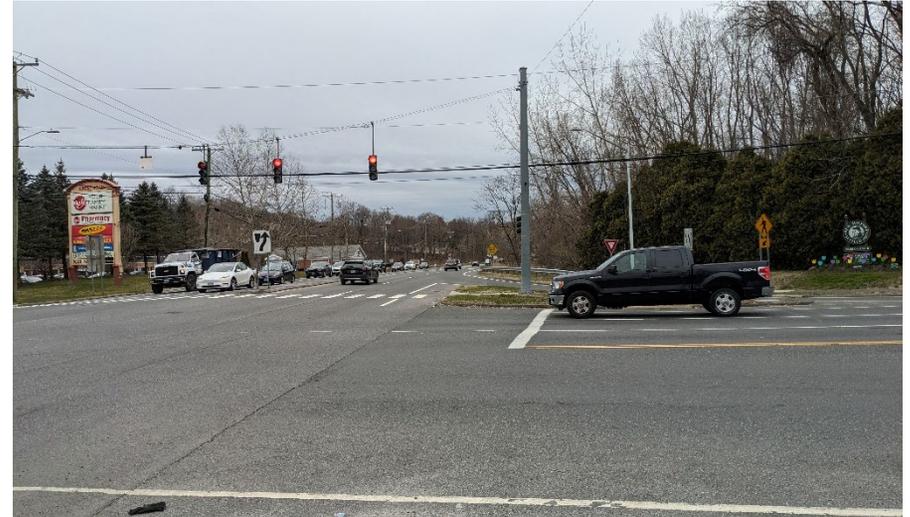
Exhibit 17: View north at intersection of US Route 7 and US Route 202

- Lack of consistent and continuous crosswalk coverage, as shown in Exhibit 17. No sidewalks are present. Pedestrian scale lighting is missing.
- High vehicle speeds, particularly on the southern approach as vehicles attempt to clear the yellow light.
- Median islands are not maintained to encourage their use.
- Many curb cuts in the vicinity to adjacent properties.

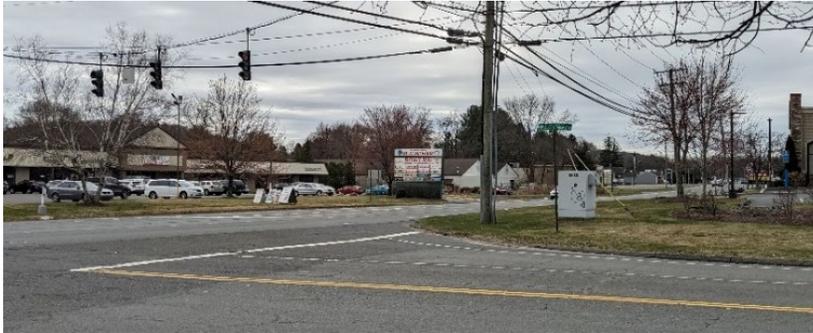
*Exhibit 18: Intersection of US Route 7 and Sunny Valley Road*

- No bicycle or pedestrian infrastructure is present including sidewalks or crosswalks, as shown in Exhibit 18. Pedestrian scale lighting is missing, and a participant stated that visibility at night is especially challenging here.
- Pedestrian signal push buttons do not have any signage and are thus difficult to locate.
- Transit users have no facilities at bus stops.

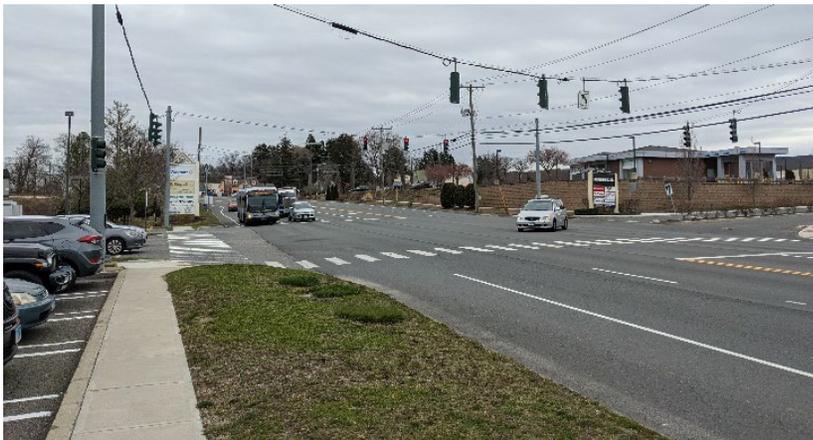
*Exhibit 19: Intersection of US Route 7 and New Milford Plaza*

- Town officials stated that this intersection has high speeds, particularly on the northern approach which is downhill.
- Pedestrian scale lighting is missing, as shown in Exhibit 19.
- There is a narrow sidewalk adjacent to the parking lot on the west side of US Route 7 that is discontinued after the plaza ends.

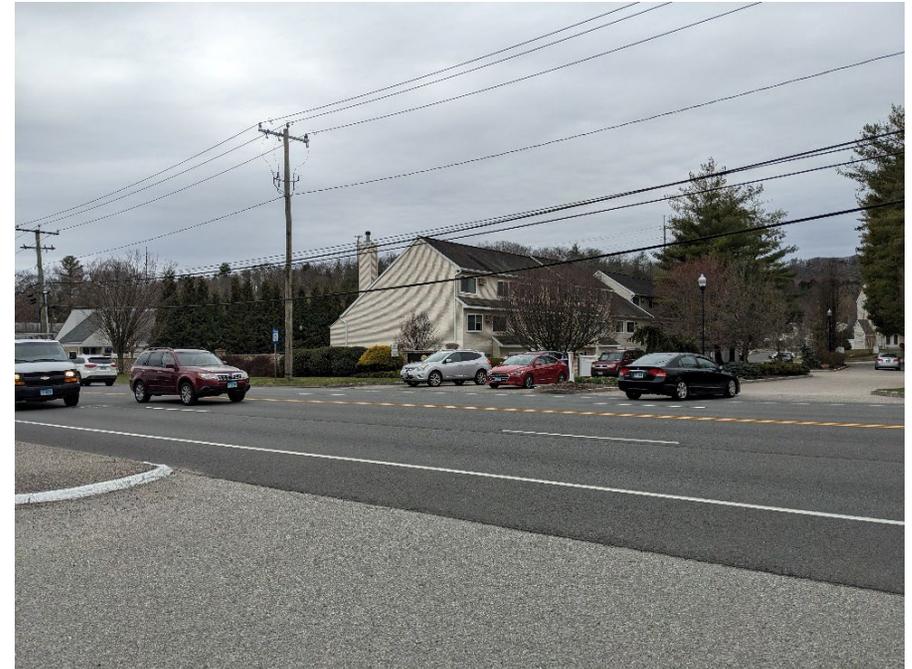
*Exhibit 20: Entrance to Willow Springs Condominiums*

- Town staff reported that residents have trouble making left turns out of the driveway on to US Route 7. Exhibit 20 displays the driveway.
- There are high vehicular speeds through this stretch of the corridor.
- There are no bicycle or pedestrian amenities, including sidewalks, crosswalks, and lighting.
- There are several curb cuts to adjacent properties.

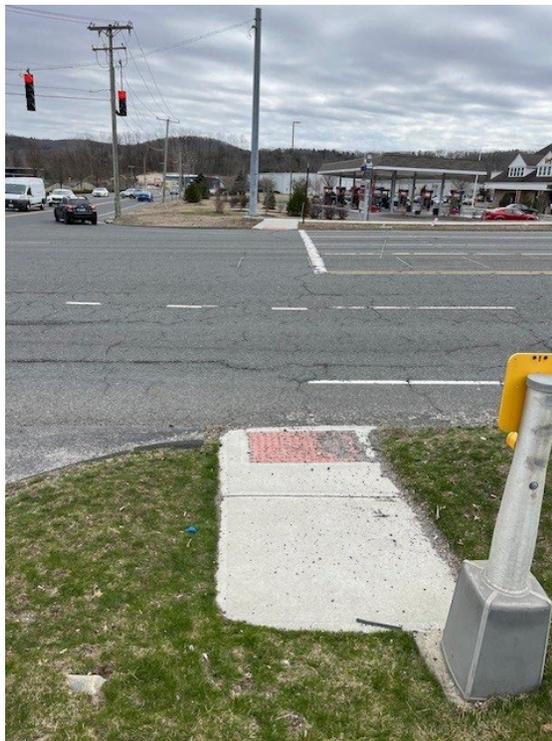
*Exhibit 21: Pedestrian Ramp and Push Button Signal*

- There are no crosswalks or sidewalks at this intersection despite pedestrian ramps and push buttons at the northbound approach to the intersection, as shown in Exhibit 21. Participants stated that pedestrians do cross the street to access businesses in the area.
- There is a bus stop located at the crest of the hill south of the intersection that has no connectivity to any other pedestrian network.
- Pedestrian scale lighting is missing.

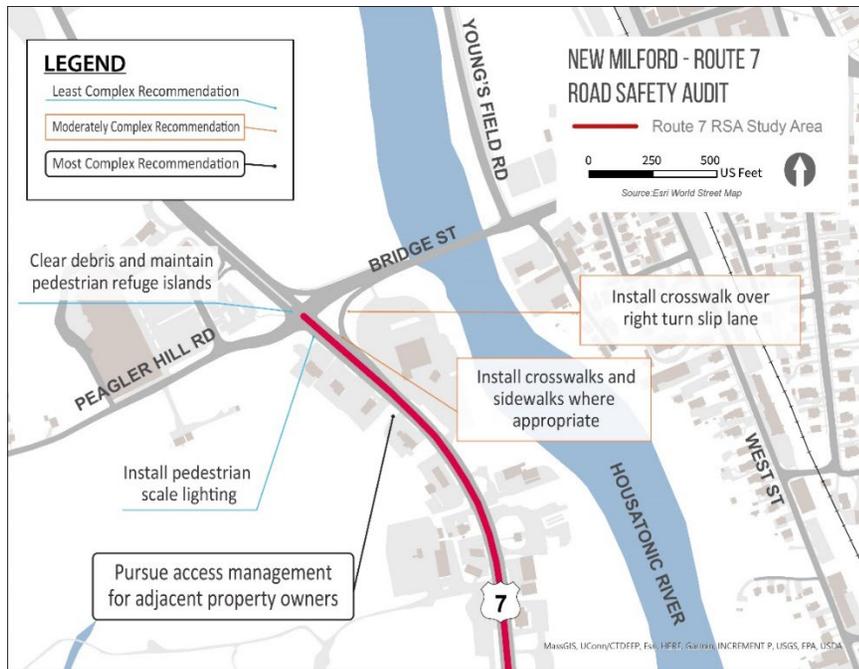
Exhibit 26: Veteran's Memorial Bridge Recommendations

Recommendations for the intersection of US Route 7 and US Route 202 focus on improving safety for vulnerable road users while recognizing this is an important vehicular connection to downtown New Milford. CTDOT has identified this intersection as part of their crosswalk and sidewalk improvement program. Exhibit 26 displays the recommendations for the area.

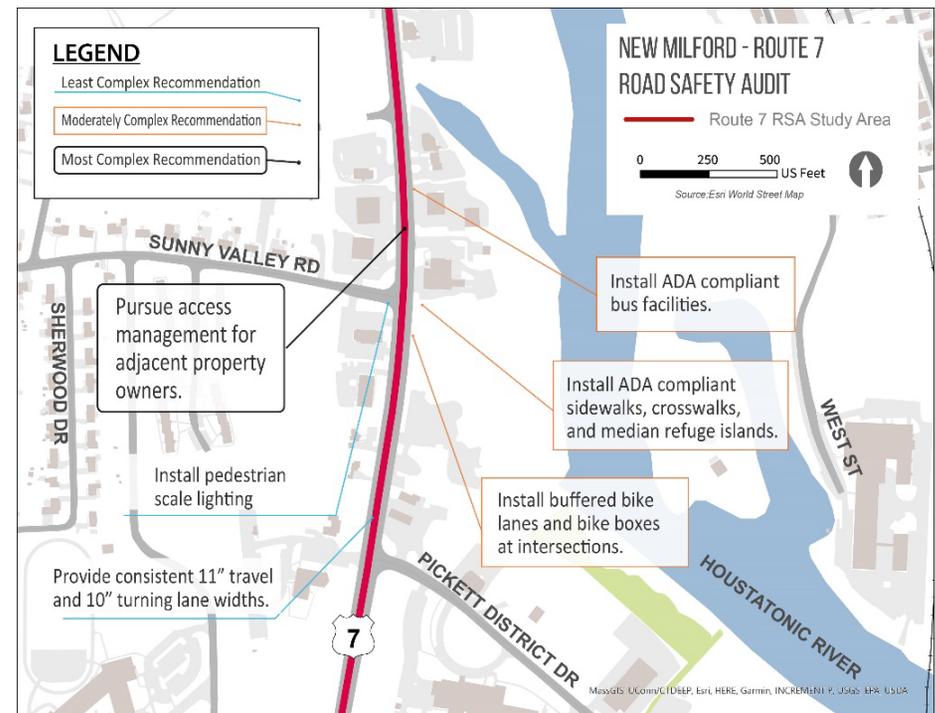
*Exhibit 27: Sunny Valley Road Recommendations*

The intersection at Sunny Valley Road has many curb cuts to adjacent properties along US Route 7. There are also no existing bicycle or pedestrian dedicated facilities. The recommendations here are focused on safety improvements for all roadway users and continuity with the remainder of the US Route 7 corridor. Exhibit 27 displays a map with the recommendations.

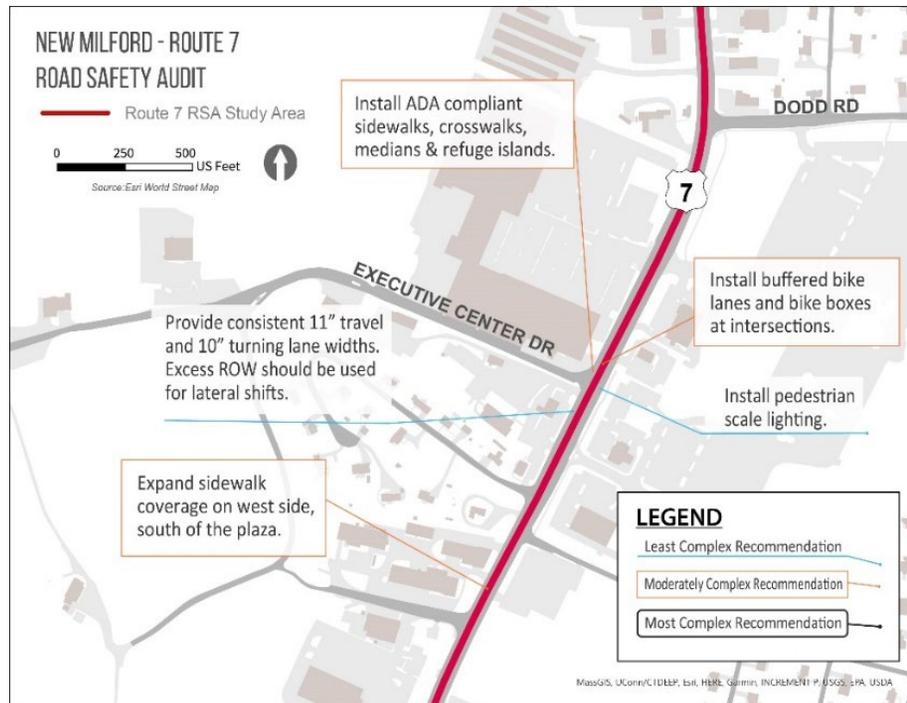
Exhibit 28: New Milford Plaza Recommendations

New Milford Plaza is busy with both through traffic on US Route 7 and turning movements in and out of commercial property parking lots. The recommendations focus on completing missing pedestrian and bicycle accommodations and slowing vehicle speeds. Exhibit 28 displays a map with the recommendations.

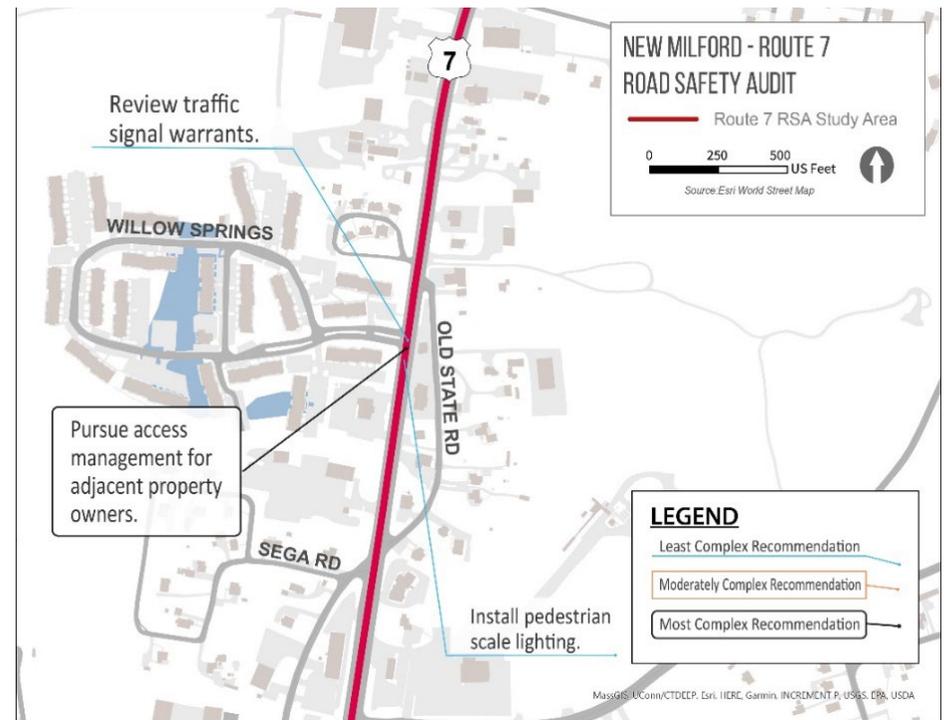
Exhibit 29: Willow Springs Condominiums Recommendations

Willow Springs Condominiums were constructed relatively recently. Recommendations at Willow Springs are displayed in Exhibit 29. The most voiced concern was to reassess the need for a traffic signal.

- 2) Create a green median to break up travel lanes in support of appropriate lane widths. S
  - **Next Step:** Municipality to contact [Western Connecticut Council of Governments Regional Planning Agency](#) for potential funding sources
  - **Next Step:** Municipality to check available ROW and roadside area for feasibility
  - **Next Step:** Municipality to coordinate with CTDOT for feasibility

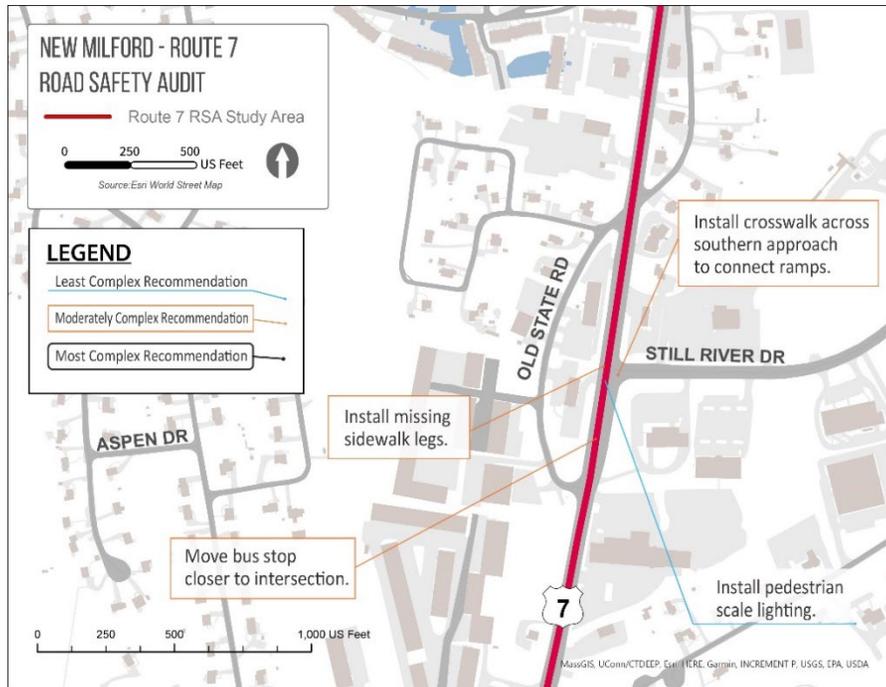
*Exhibit 30: Still River Drive Recommendations*

US Route 7 and Still River Drive are at the base of a hill with high vehicle volumes and speeds over the crest going north at the approach to the intersection. Recommendations here focus on completing pedestrian accommodations where the ROW allows and implementing more appropriate safety measures as shown in Exhibit 30.

- **Next Step:** Municipality to consider applying for an [Encroachment Permit](#) through the District permit office
- 2) Install missing sidewalk legs along the western side of US Route 7 and the eastern side north of Still River Drive.

- 3) Move bus stop closer to intersection for better access to crosswalks and other pedestrian facilities. Upgrade ADA-compliance with applicable standards.

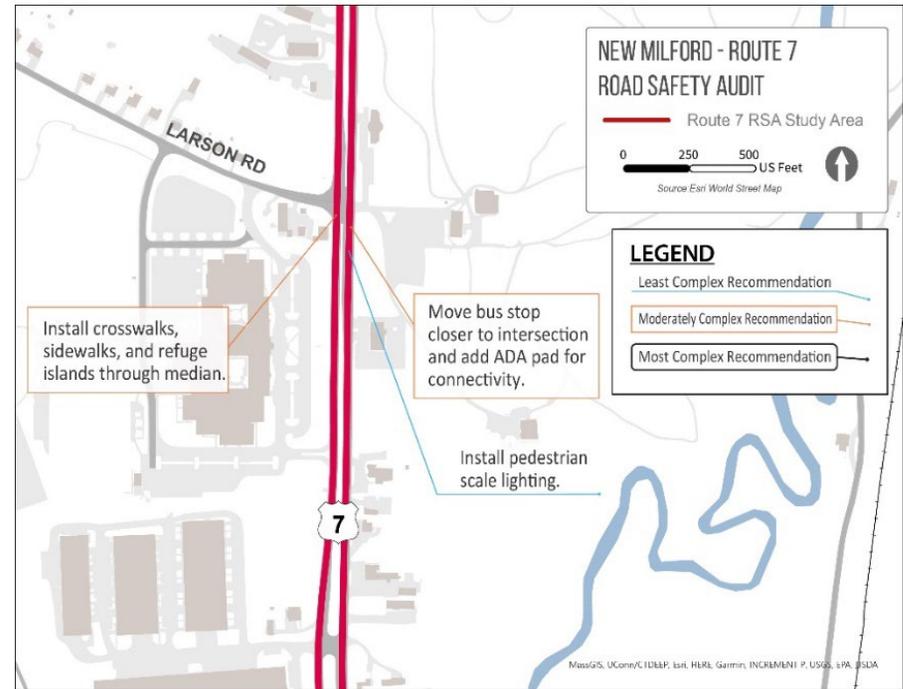
Exhibit 31: New Milford High School Recommendations

New Milford High School is located on a stretch of US Route 7 that is straight and flat with a median that encourages speeding by giving the roadway a highway feeling. Recommendations here focus on completing pedestrian accommodations where the ROW allows and implementing more appropriate safety measures, as shown in Exhibit 31.
