**PHASE IA ARCHAEOLOGICAL
SURVEY**

**NEW MILFORD RIVER TRAIL
NORTHERN AND SOUTHERN
SECTIONS**

**BOARDMAN ROAD TO
BROOKFIELD BORDER**

NEW MILFORD, CONNECTICUT

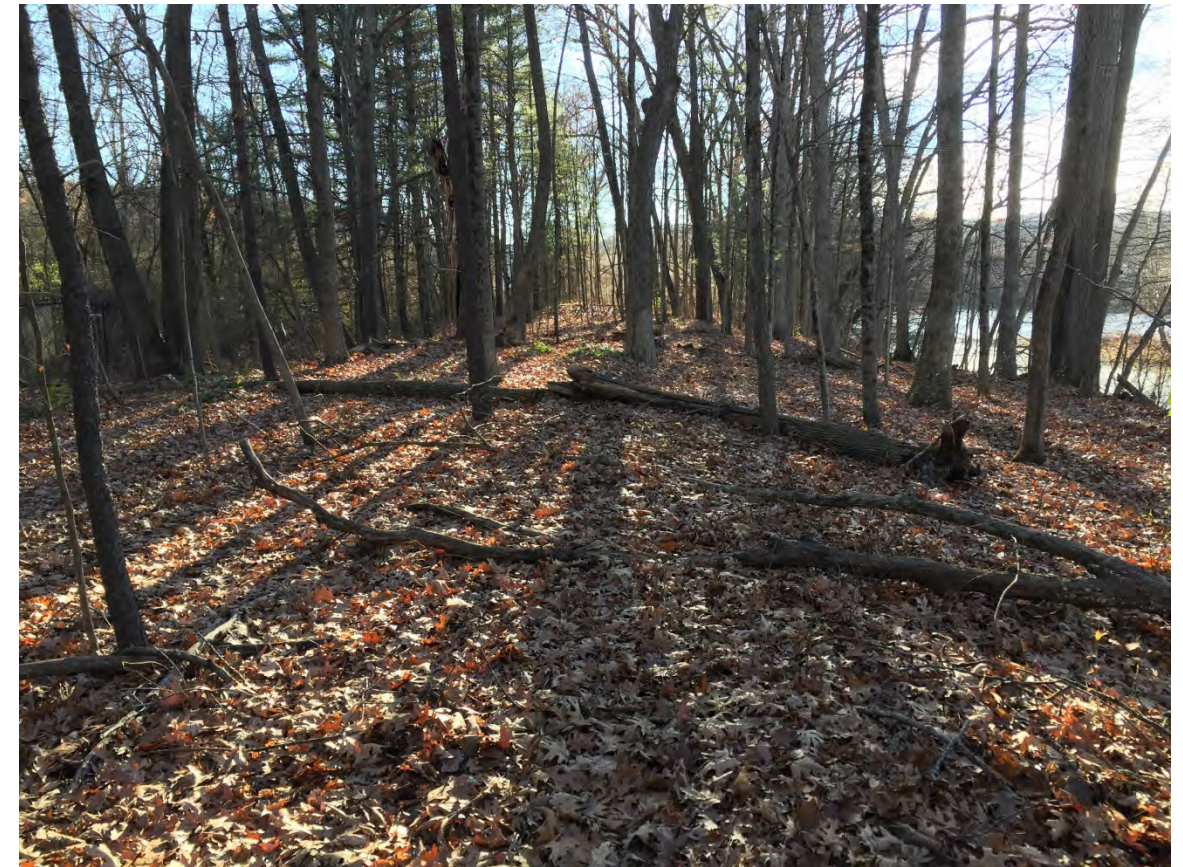
Photograph N3: Facing south to a level terrace between the Housatonic River, at right, and railroad tracks to the left and out of the photograph. This area is wooded and has a semi-cleared path, possibly an abandoned road used for access to fishing spots or for nineteenth-century railroad construction.

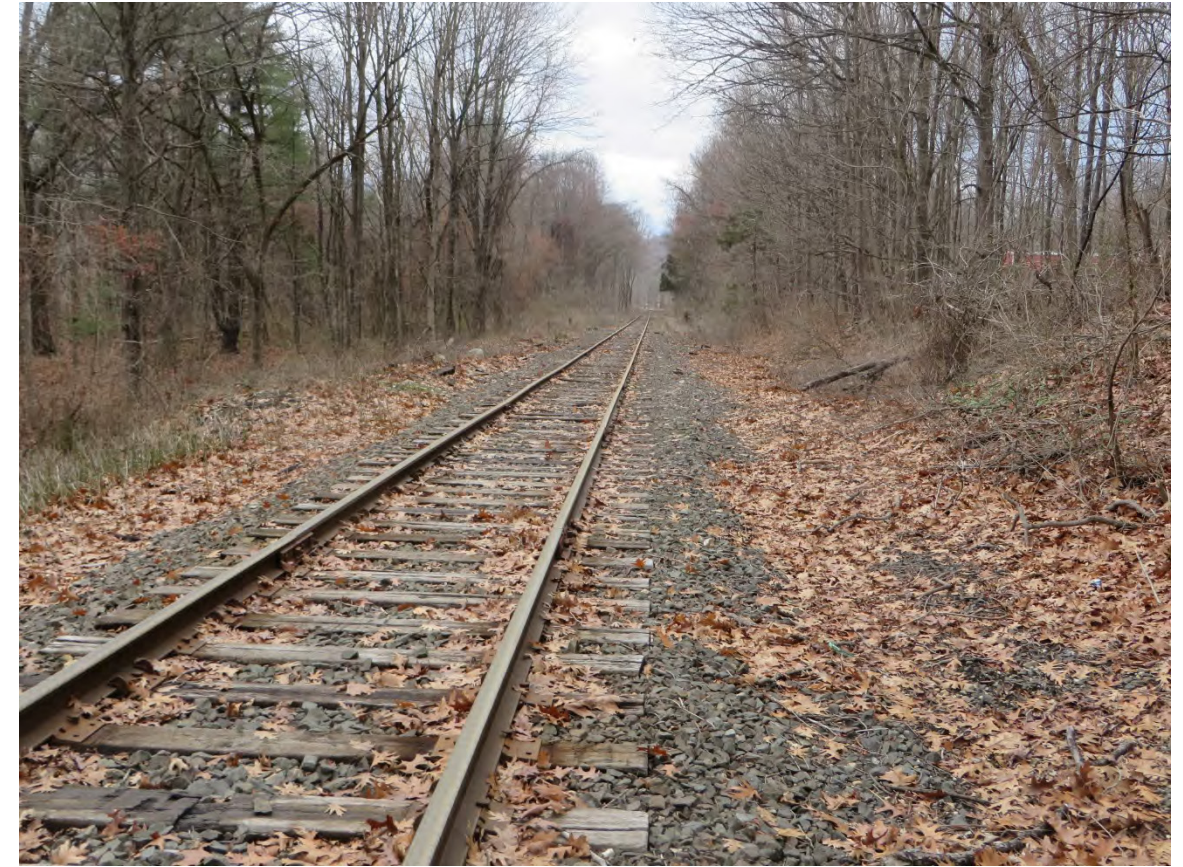
Photograph N7: Facing north to railroad cut into the terrain, with an embankment down at left, and an embankment up at right.

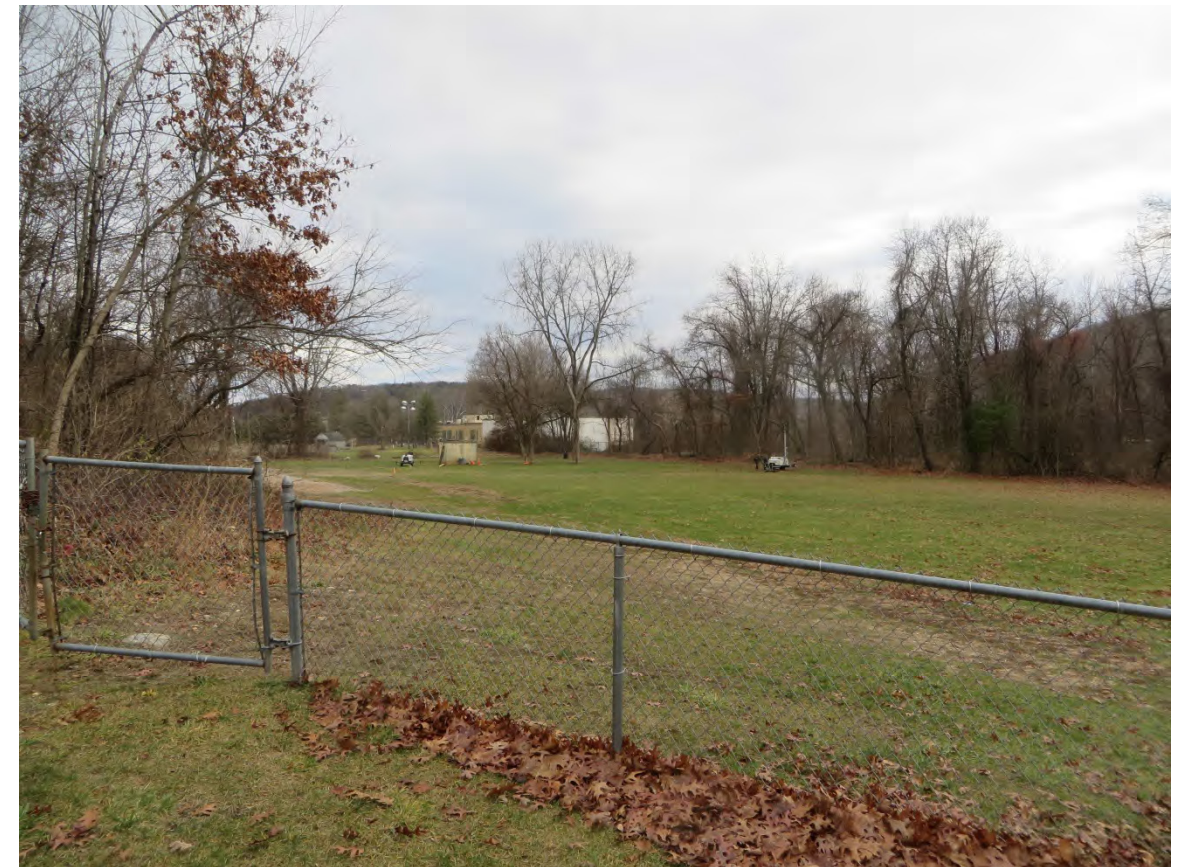
Photograph N8: Facing southwest to a field at the north end of MEDInstill property, east of the railroad tracks.

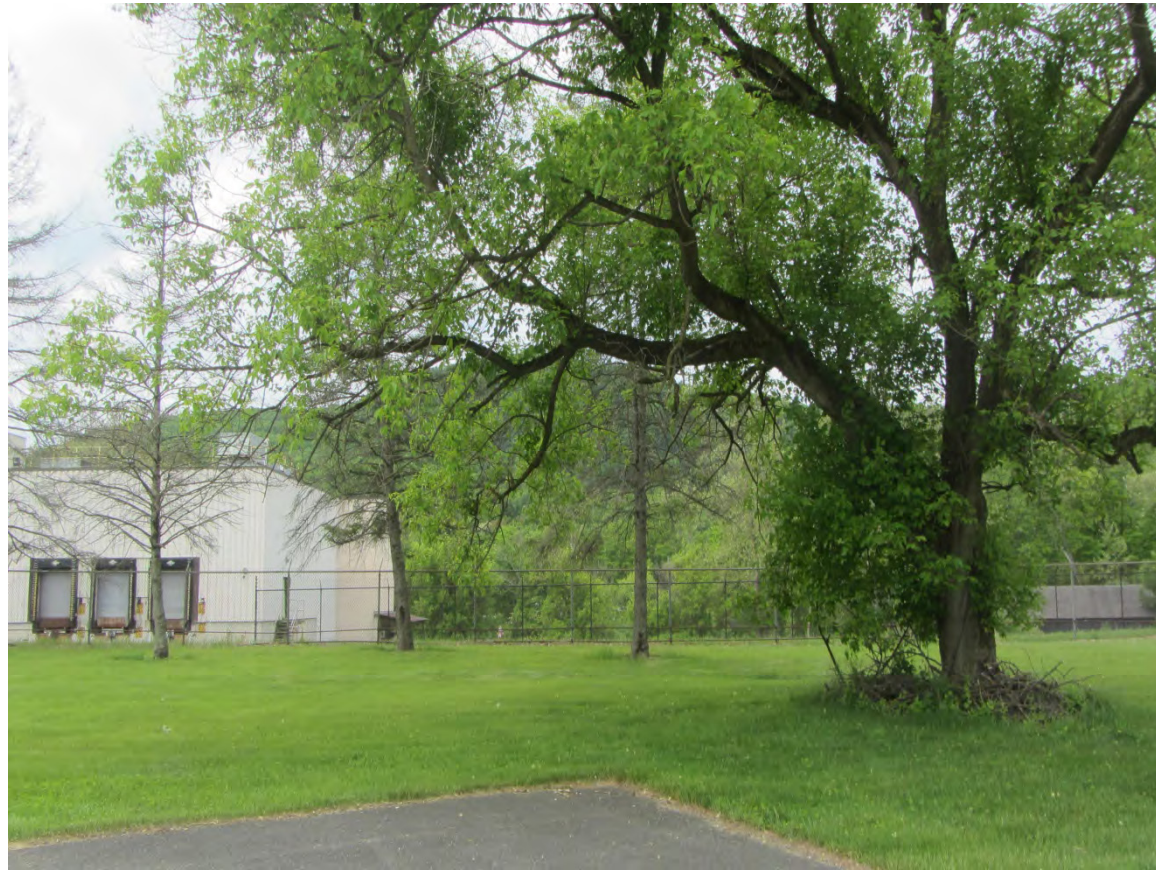
Photograph N9: Facing southwest toward two unused buildings at the north end of the MEDInstill property, both to the west of the railroad tracks.

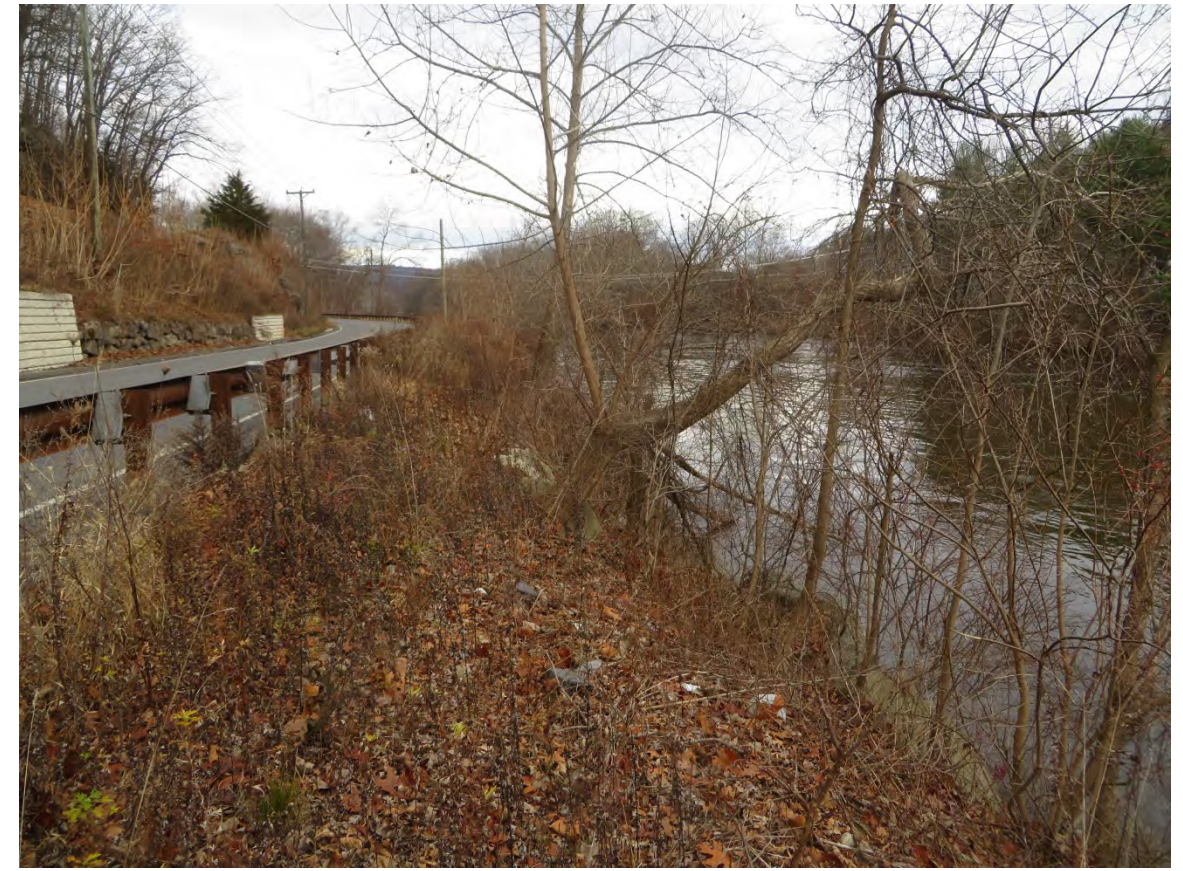
Photograph N11: Facing east to a narrow "choke" point where, from left to right, the railroad tracks, Boardman Road, and the Housatonic River closely align.

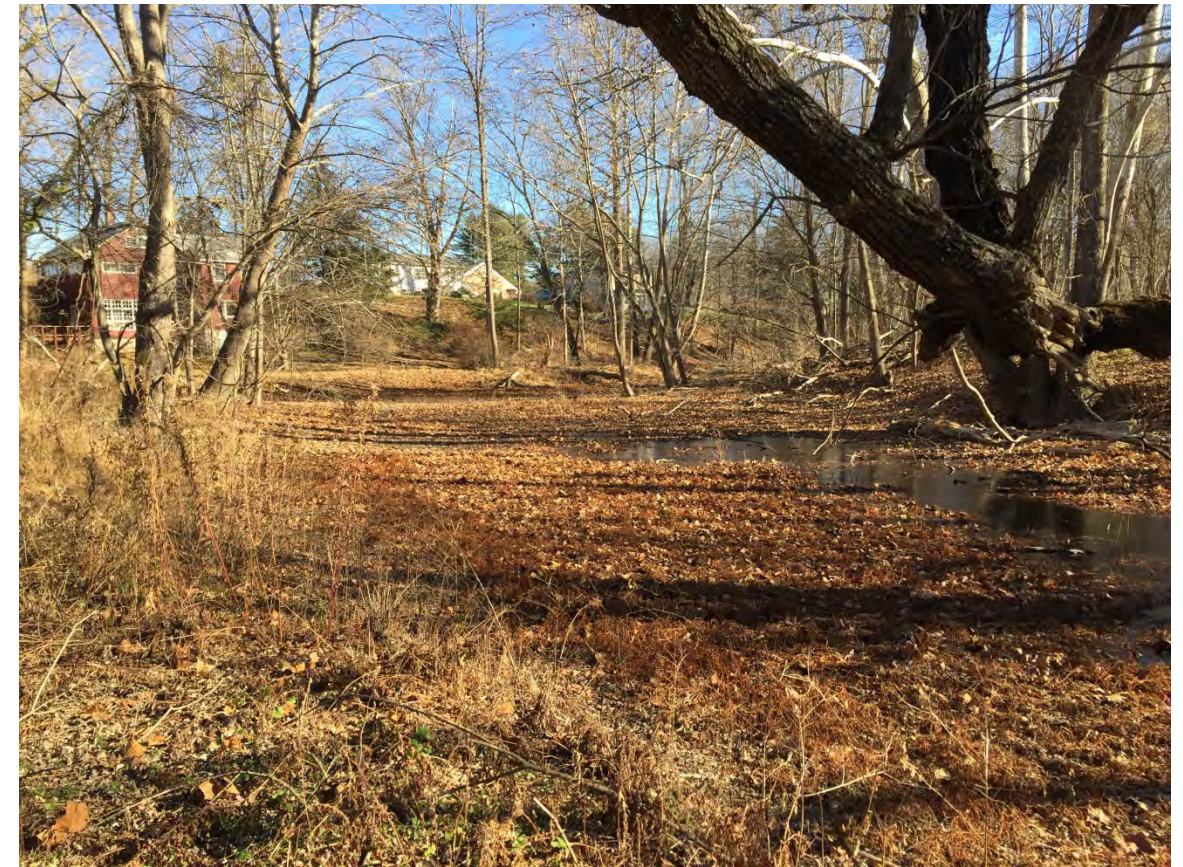
Photograph N15: Flooded area separating Wannuppee Island from the upland terrace and the course of Housatonic Avenue, facing northeast.

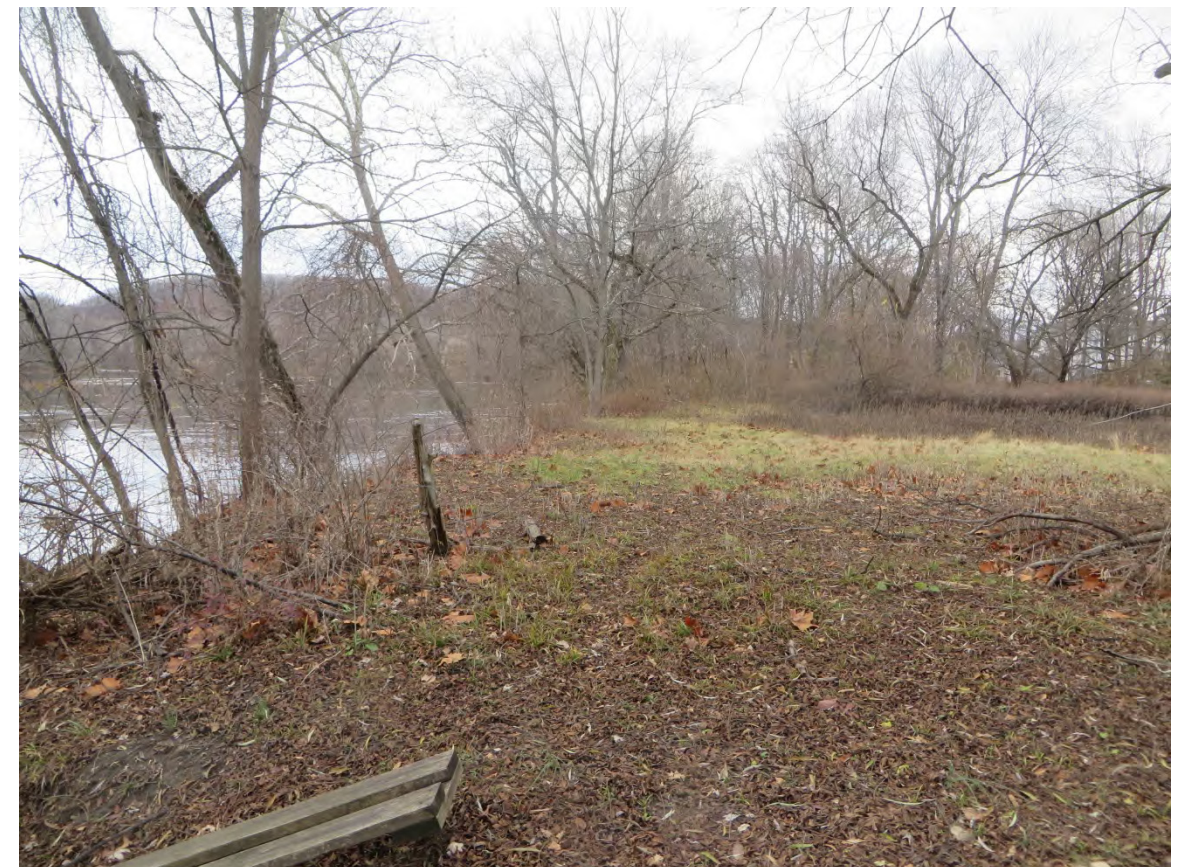
Photograph N16: Wooded level area to south of Wannuppee Island, facing northwest with the Housatonic River at left.

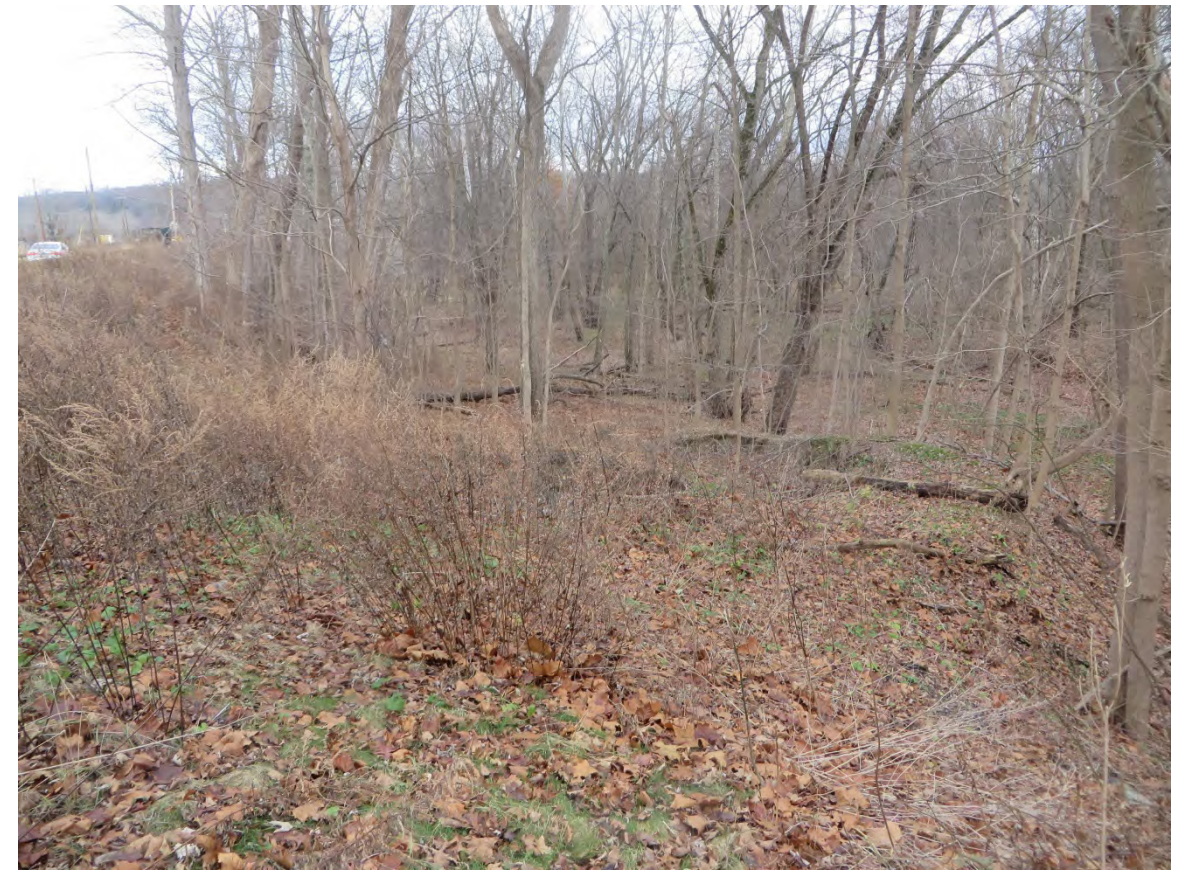
Photograph N20: Wooded area on the south side of Housatonic Avenue and east of the choke point where the road, railroad tracks, and river are in close proximity, facing south.

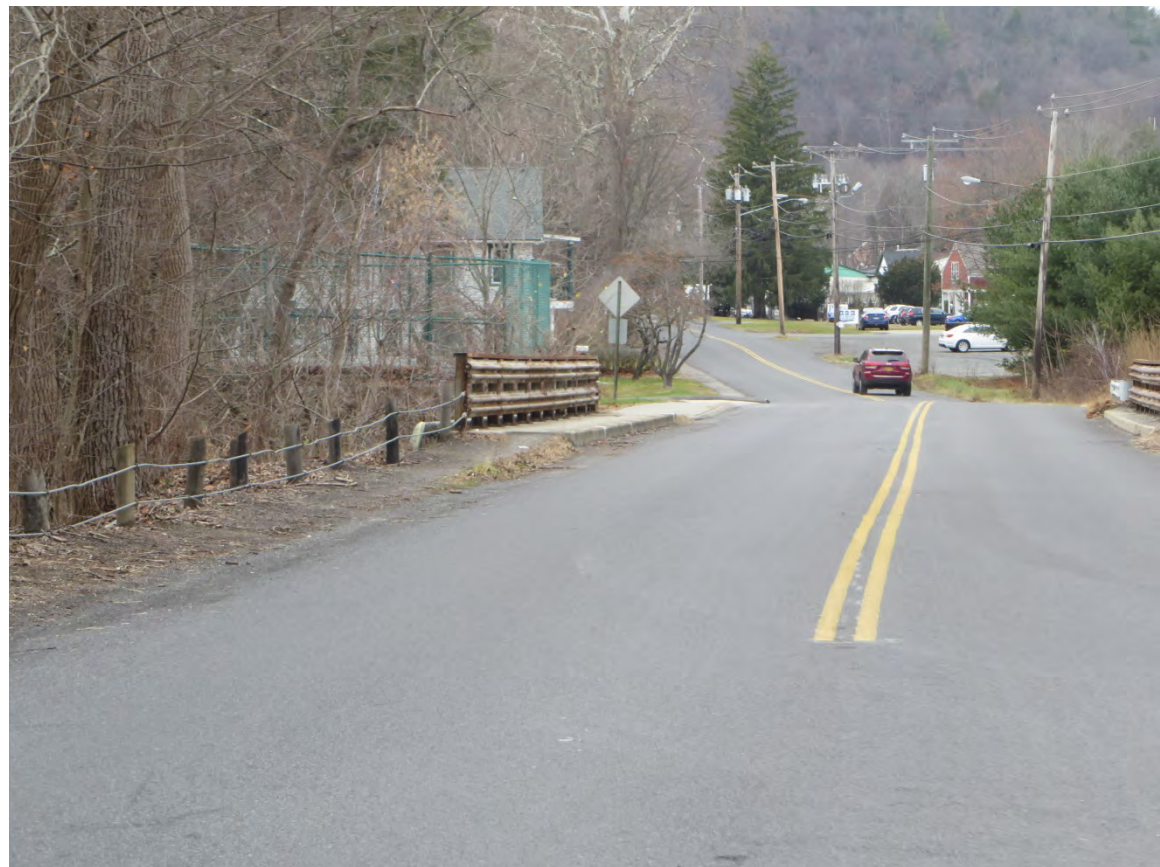
Photograph N22: Facing northwest from the center of Housatonic Avenue toward a small bridge crossing over the West Aspetuck River.

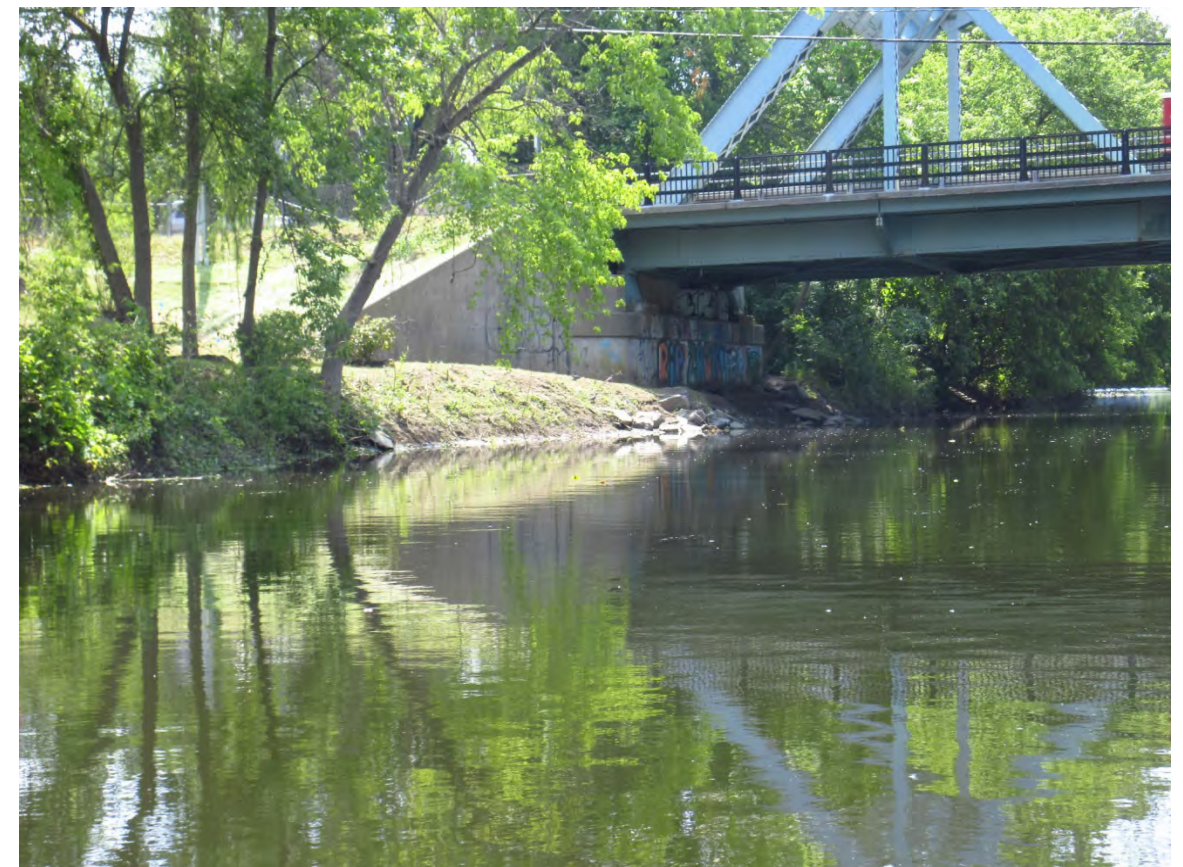
Photograph S6: Potential route of trail beneath the east side of the Bridge Street Bridge, immediately adjacent to the Housatonic River, facing southeast.

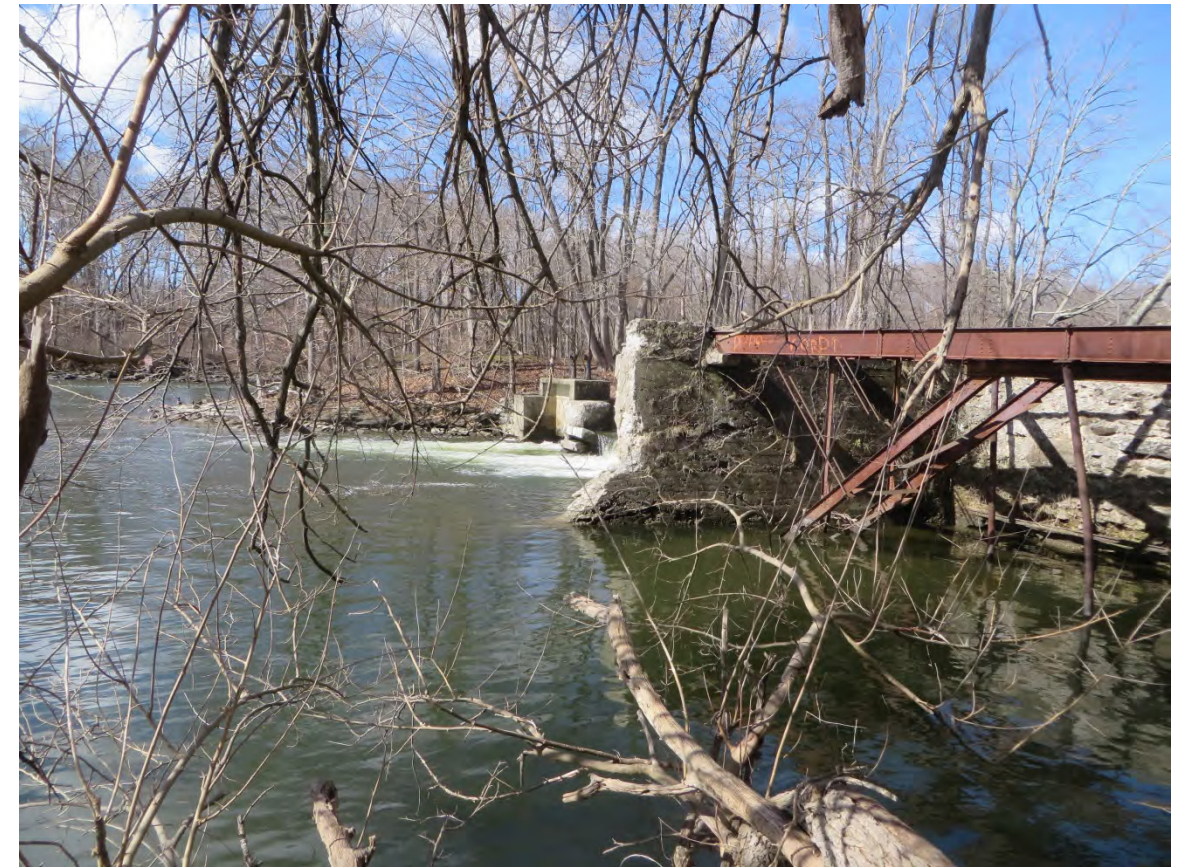
Photograph S9: Remains of eastern portion of Bleachery Dam adjacent to the mill building in Hidden Treasures Park, facing northwest.

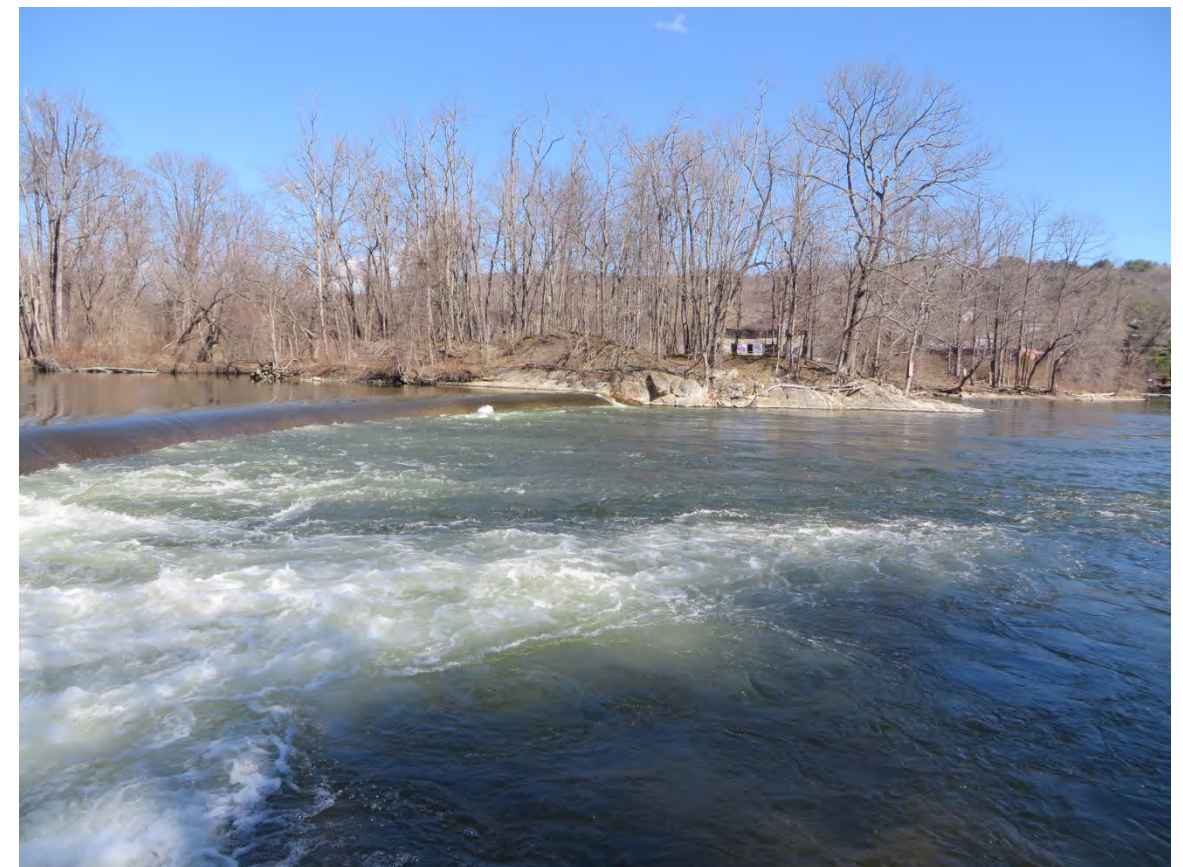
Photograph S10: Facing east from the west bank of the Housatonic River to the western section of the Bleachery Dam on the Housatonic River and, on the opposite side of the river, Hidden Treasures Park.

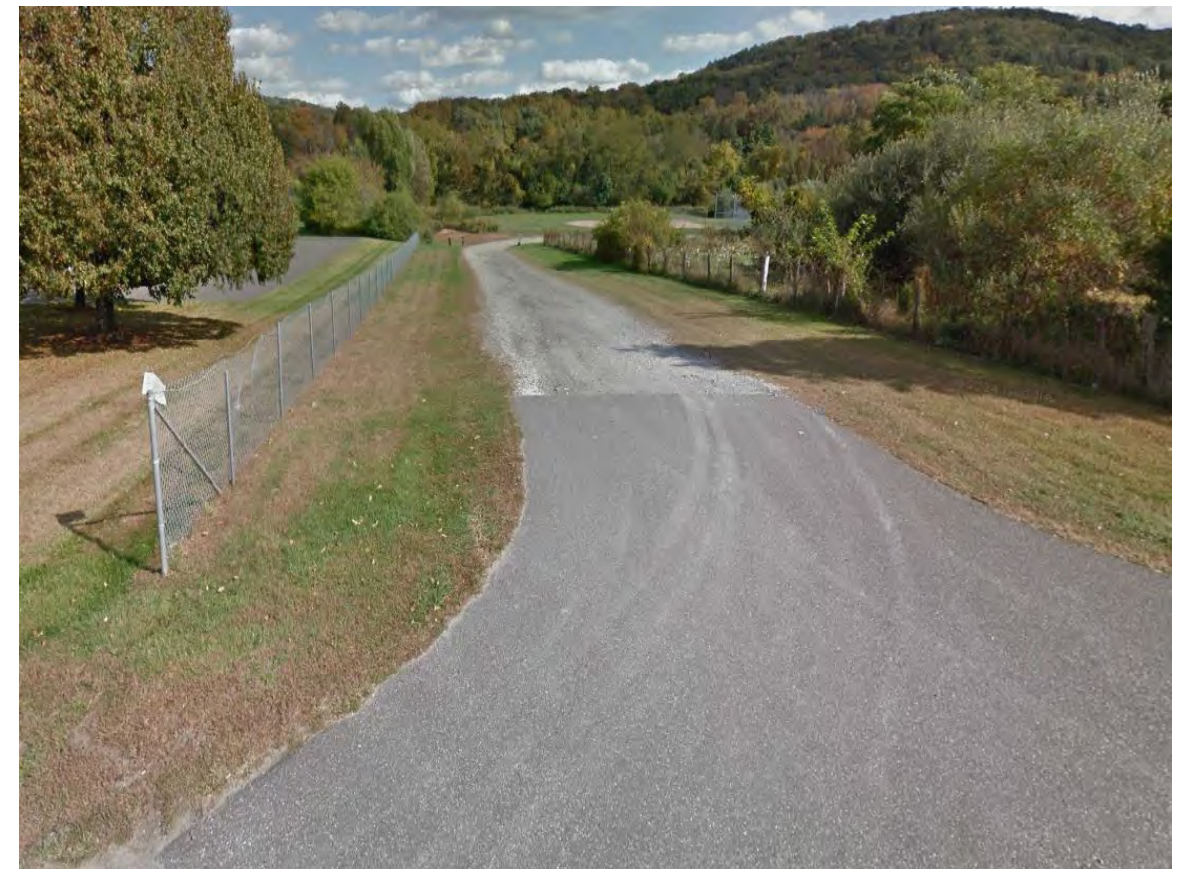
Photograph S14: Gravel road, facing east downhill from Pickett District Road to Town owned ballfields and potential route of trail.

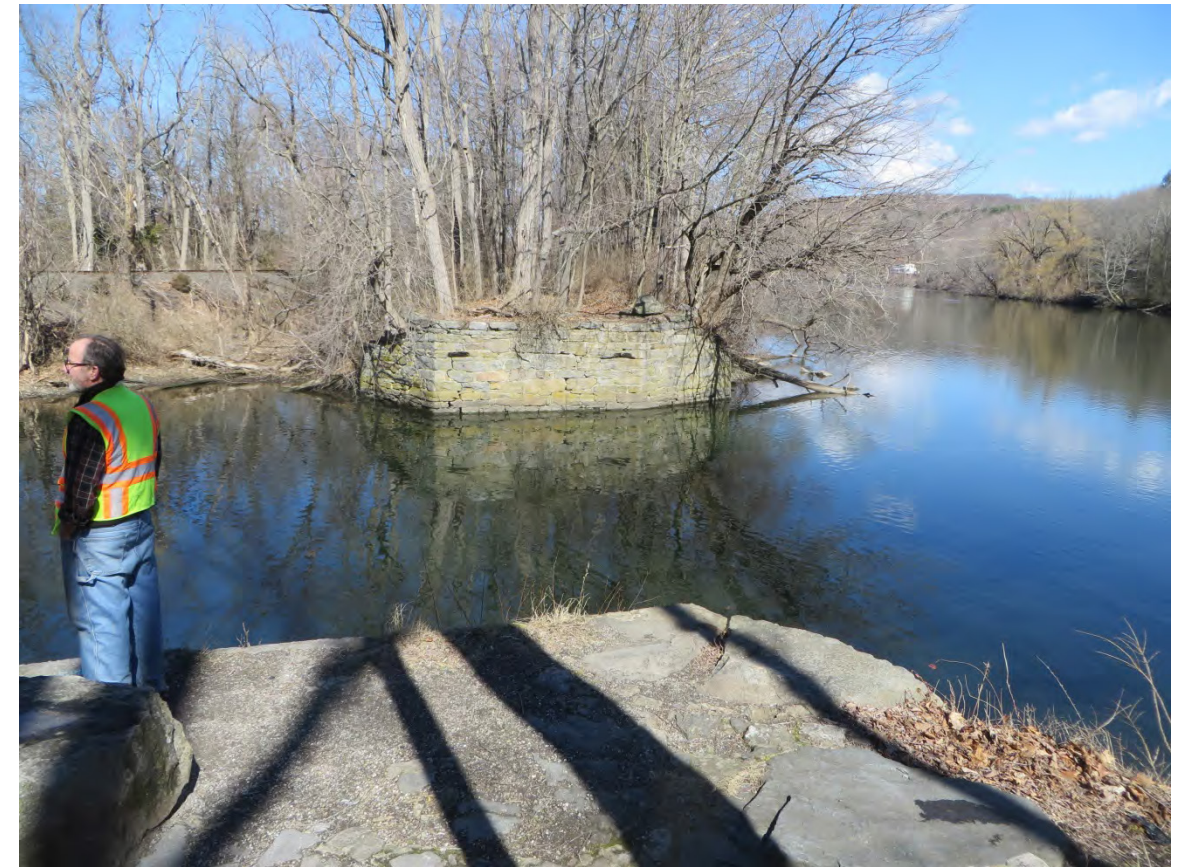
Photograph S17: Historical bridge abutment for former railroad crossing at the mouth of the Still River where it enters into the Housatonic River, facing north.

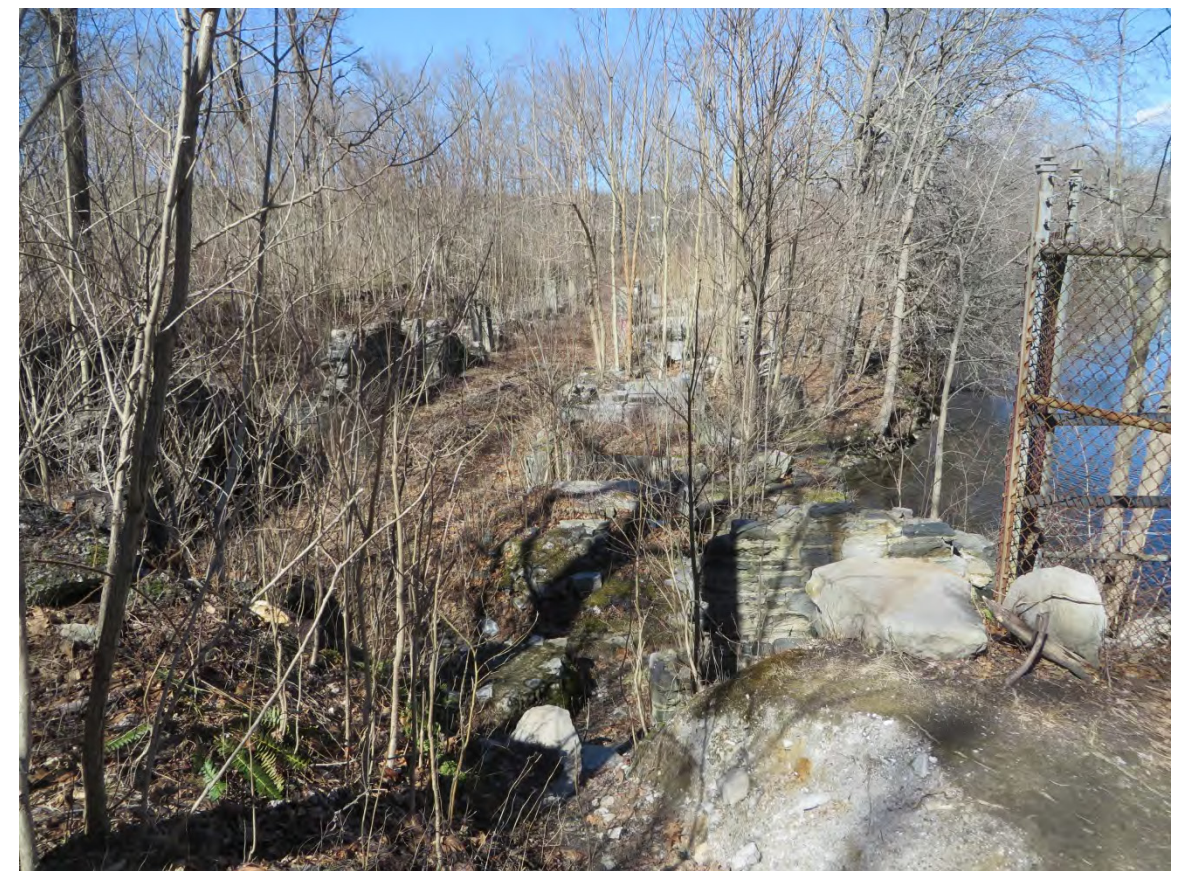
Photograph S18: Facing north to the Bridgeport Wood Finishing Company site, both on the State Register of Historic Places and a Connecticut Archaeological Preserve.

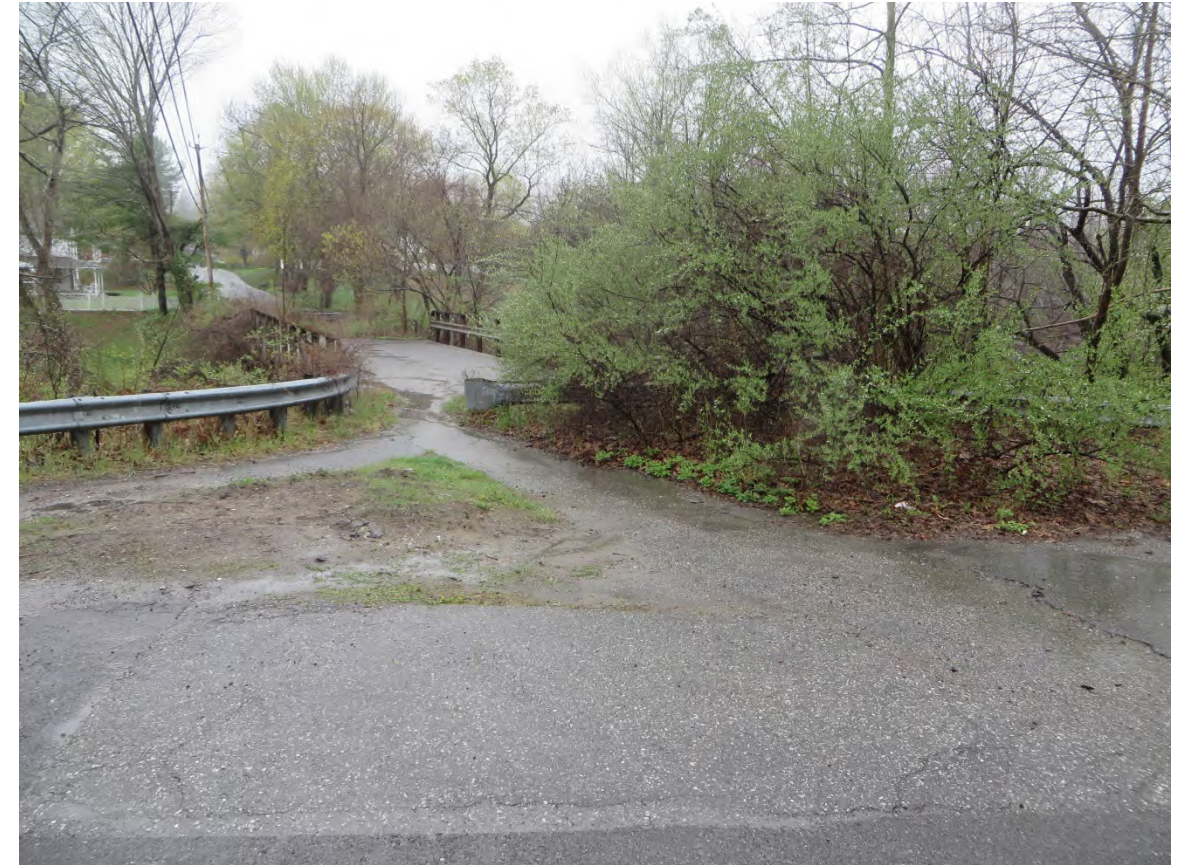
Photograph S21: Facing southwest to the Lanesville Road Bridge over the Still River at the south end of Frank's Lane and Harrybrooke Park's northern parking lot.

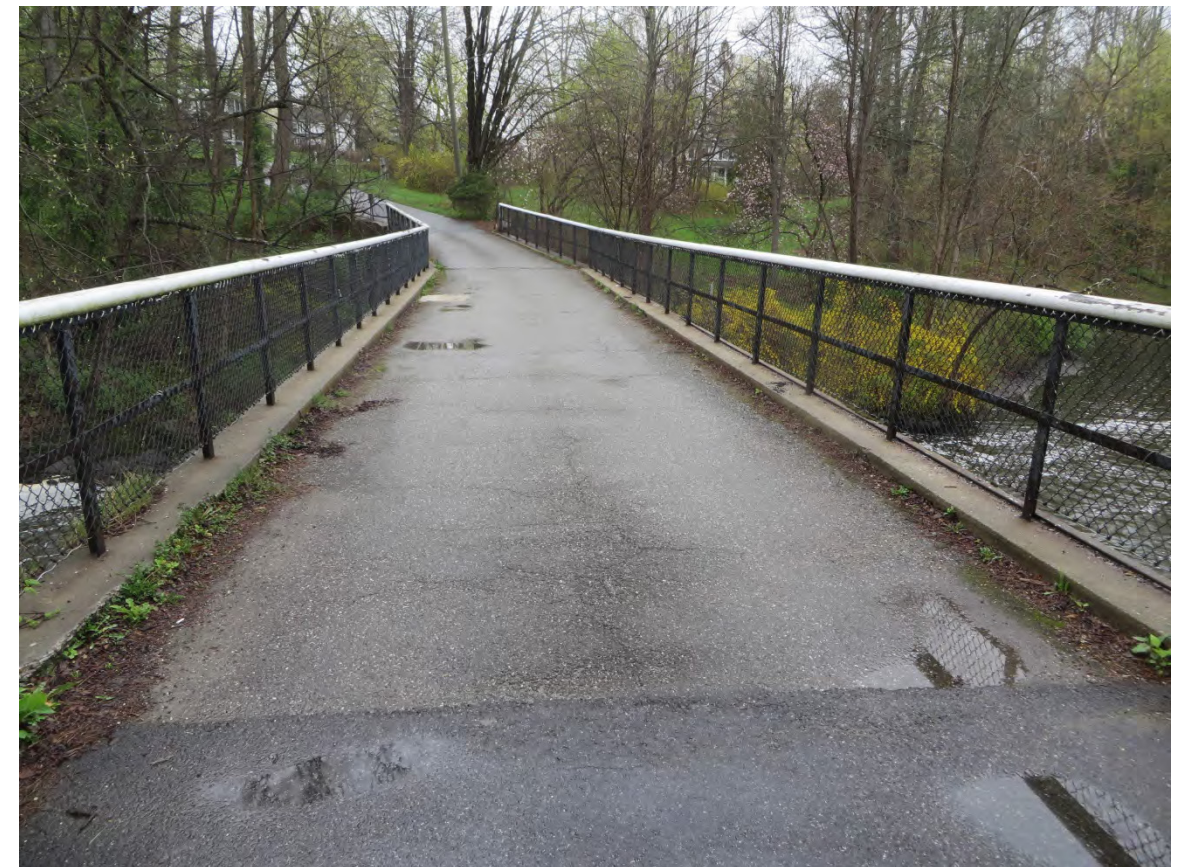
Photograph S22: Facing northwest to the existing Harrybrooke Park Bridge over the Still River that exits onto Lanesville Road.
